Executive Summary

Structural Investigation and Stability Analysis

THE ROYAL BANGKOK SPORT CLUB

(From year 2010-2020)

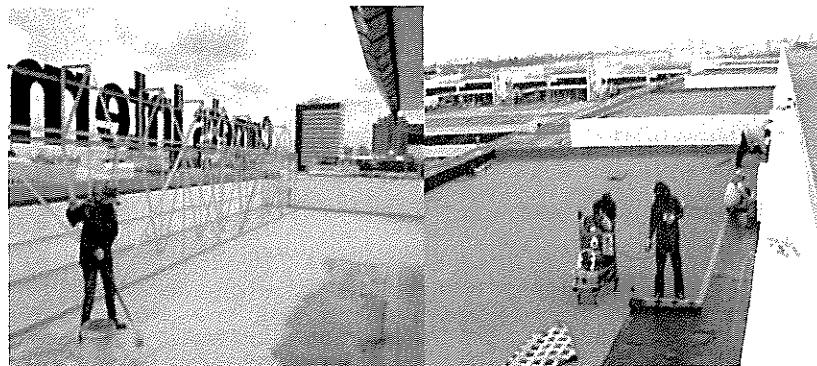
รูปที่ 3 วัสดุกันซึมบนดาดฟ้าด้วยการทาเคลือบหรือแผ่นสำเร็จรูป

5.2.2 ครอบความชื้น (ความเสียหายประเภทที่ 4) แนะนำให้ปรับปรุง การระบายน้ำในช่วงที่ฝนตกมาก ให้น้ำฝนระบายนอกจากอาคาร อย่างรวดเร็ว ไม่ให้มีน้ำขังบนกันสาด/พื้นดาดฟ้า ติดตั้งระบบกัน ชื้นที่เหมาะสมบนหลังพื้นกันสาดหรือพื้นดาดฟ้า อาทิ วัสดุประเภท ทาเคลือบแบบทนต่อรังสียูวี โดยวัสดุทาเคลือบจะกล้ายเป็นฟิล์ม บางๆ ประมาณ 1000 ไมครอน หรือหากว่าน้ำ หรือประเภทแผ่น Membrane สำเร็จรูป ที่มีทั้งชนิดแผ่นมีการในตัวแบบ เต็มแผ่น (Fully bond) และเททับด้วยคอนกรีตทับหน้าเพื่อป้องกันรังสียูวี หรือแผ่นปูและเชื่อมรอยซ้อนทับด้วยความร้อน (Torch on system) ซึ่งมีราคาสูงกว่าแต่ไม่ต้องเททับด้วยคอนกรีตทับหน้าเพื่อ ป้องกันรังสียูวี

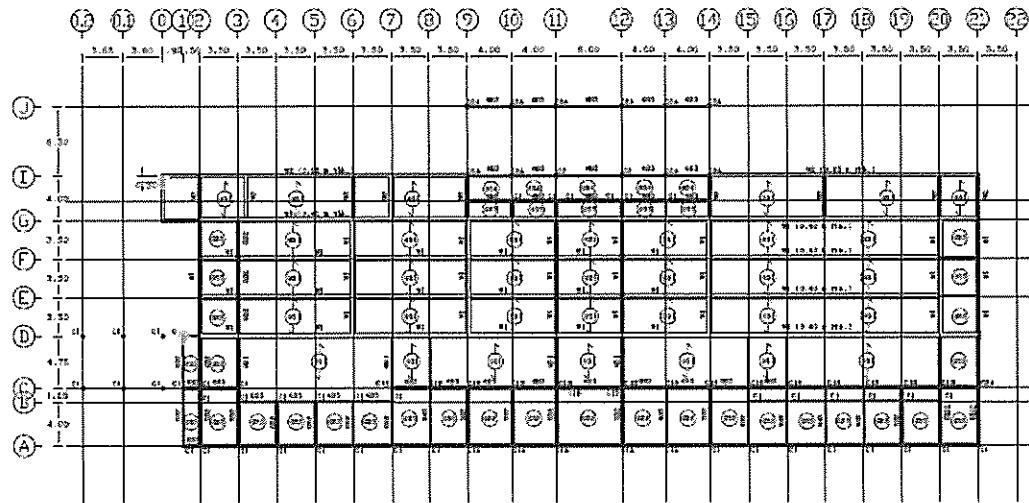
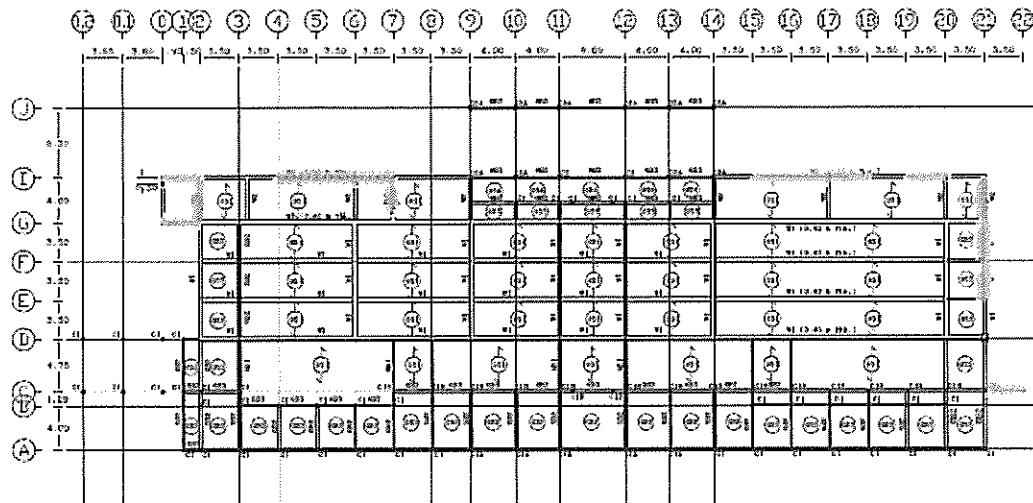
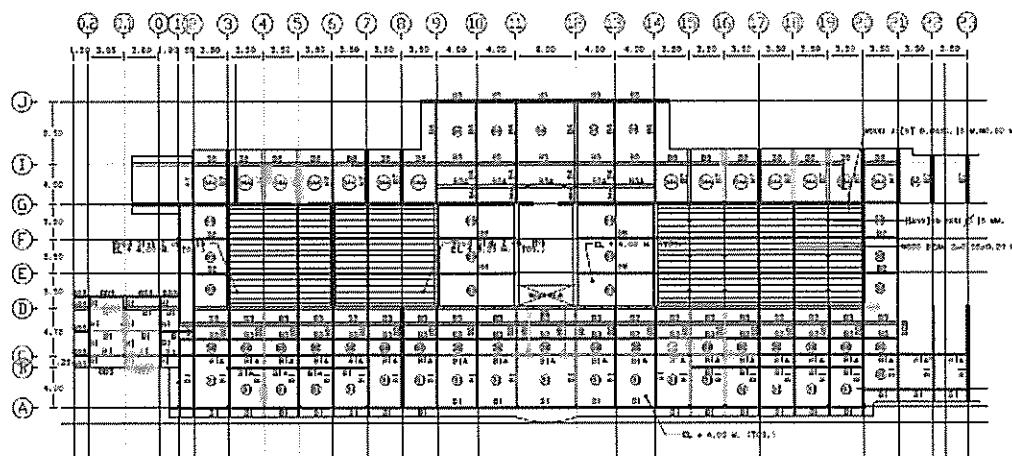
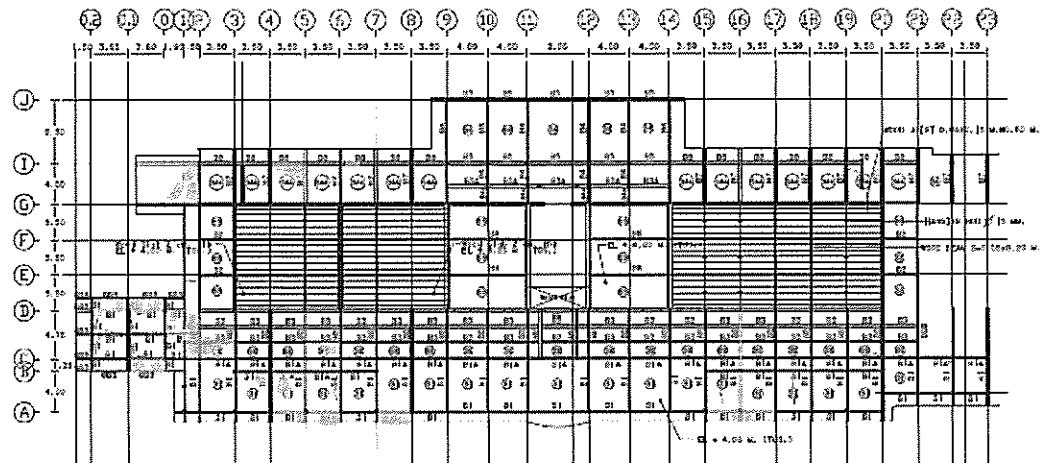
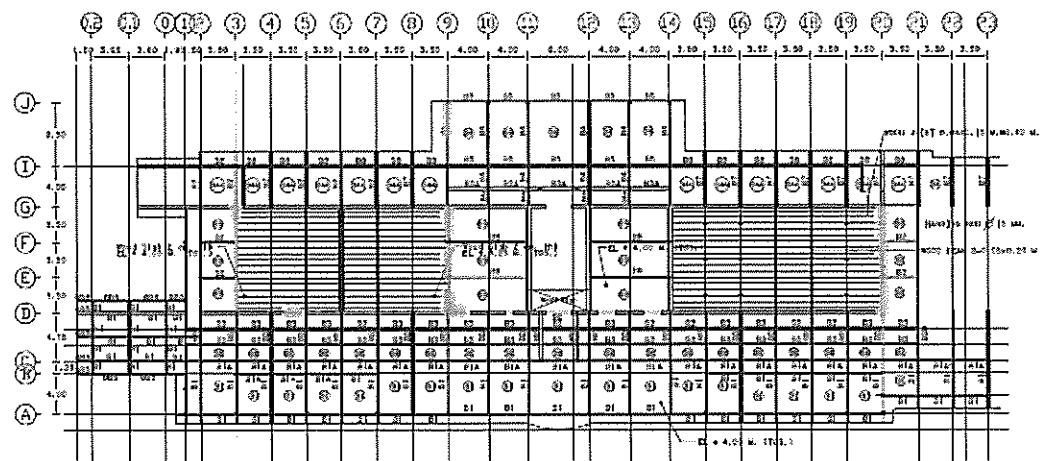
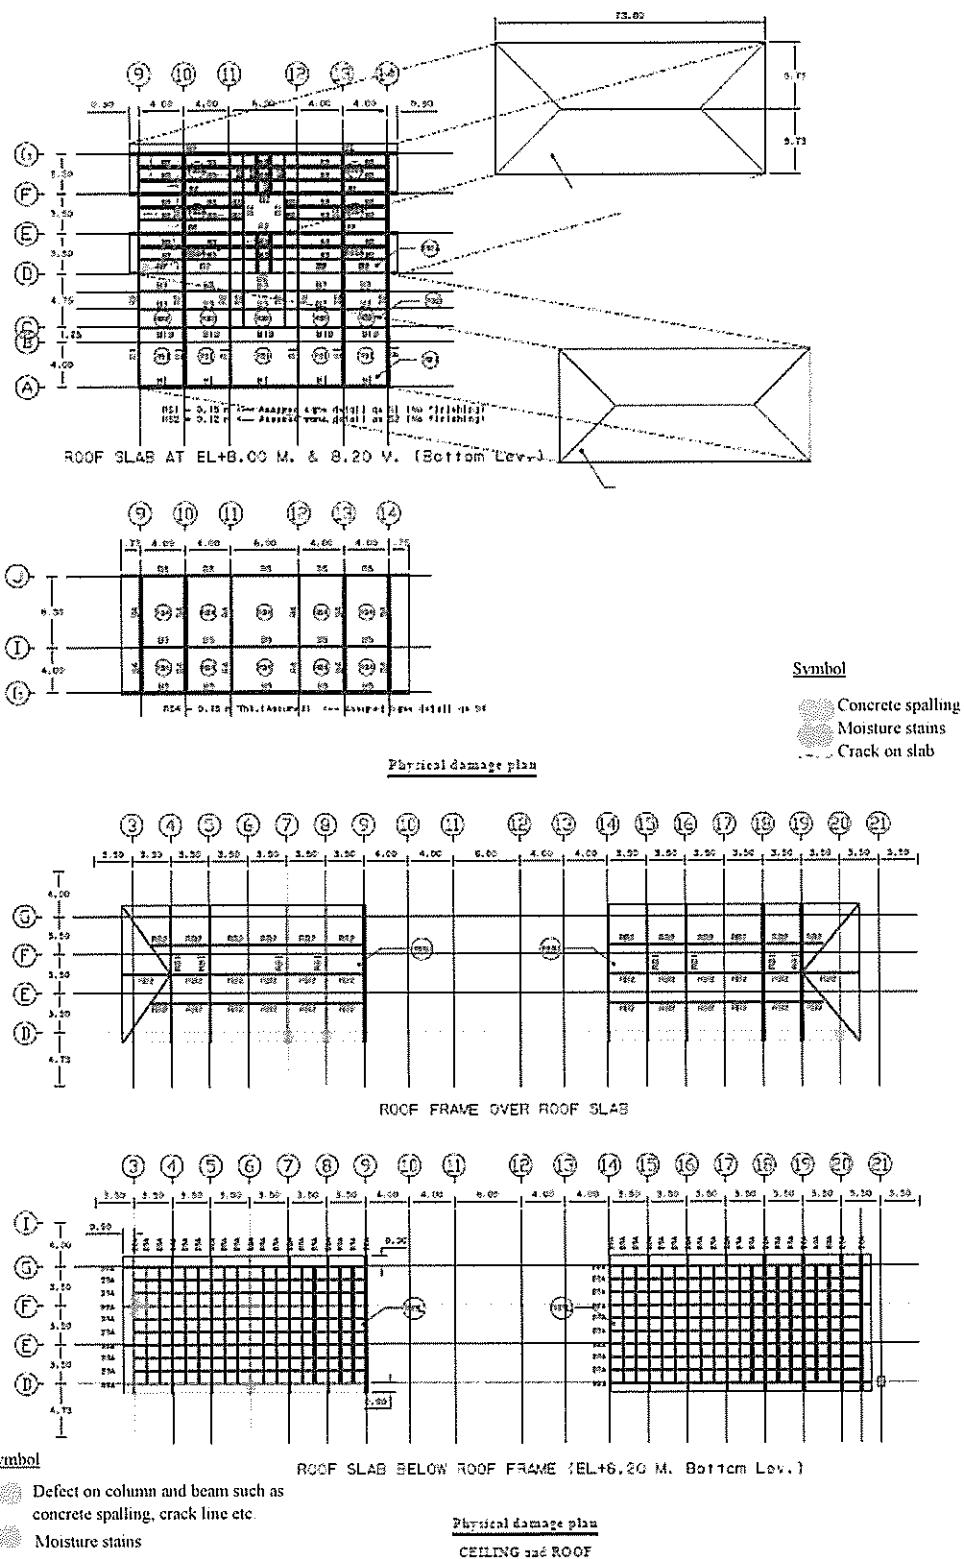
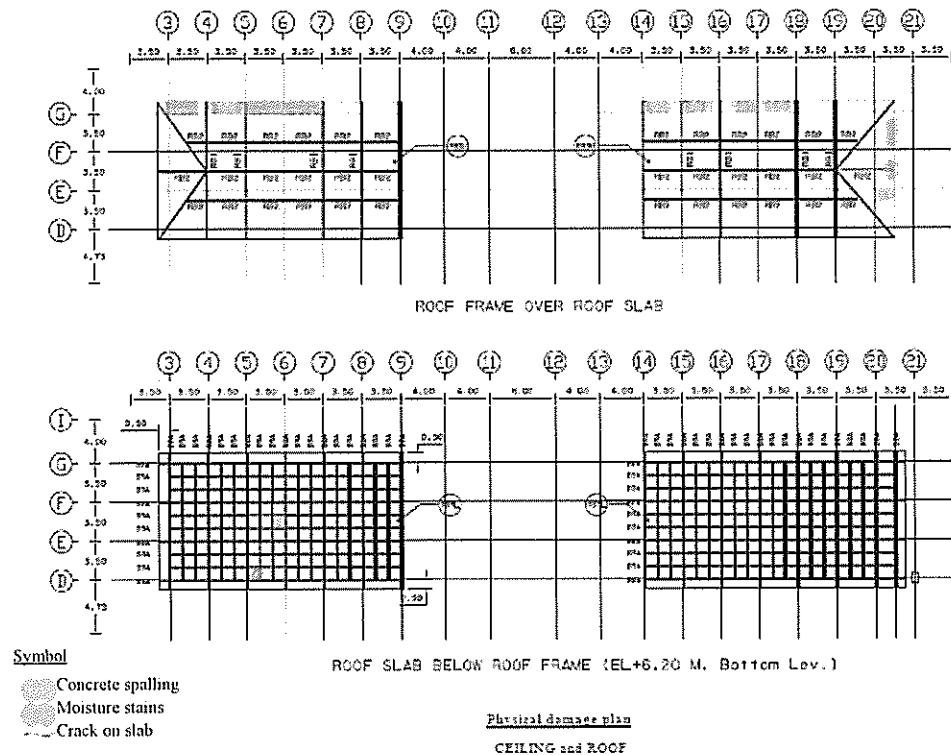
Figure 01 Physical damage recorded.

The current physical damage (Defect), found on this inspection (year 2019), were summarized in Fig 01 below.

- 7.2 All physical distresses, found and recorded in table 1, shall be rectified by proper method or as suggested below.
- 7.2.1 Concrete spalling and/or rebar corroded exposed (distress type 1) are assumed cause by **corrosion of rebar**. It is recommended to repair by conventional patch and repair (CPR). The detail method of repair can be referred to *Standard No. 1901-51 (Concrete Repair Standard)* issued by Department of Public Works and Town & Country Planning, Ministry of Interior as described below.

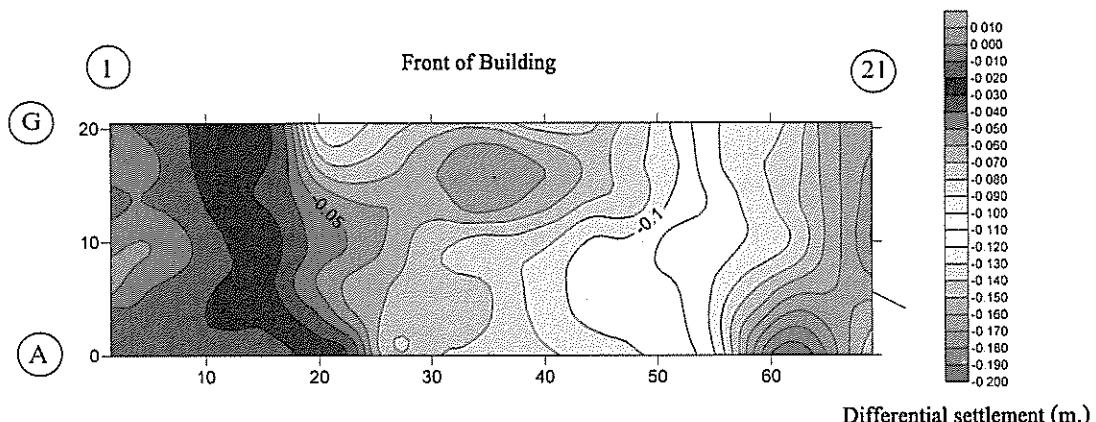
Inclination plan of ground floor and upper floor, measured on different period are summarized in Table 02 below. In general, the average building plane are stable and within acceptable range (less than 1:300). However, the potential of differential settlement is detected as indicated in Fig 02 and Fig 03 below.

Figure 02 Differential settlement contour for 1st floor

- 7.3 Long term settlement monitoring is recommended to carry out at least once a year in order to observe the progress of differential settlement which found in the north wing of the building.

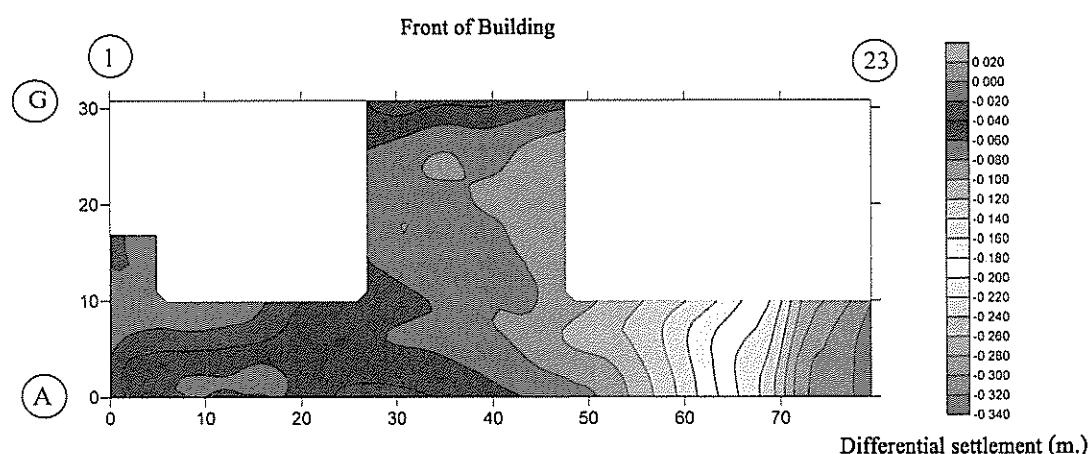
Figure 03 Differential settlement contour for 2nd floor

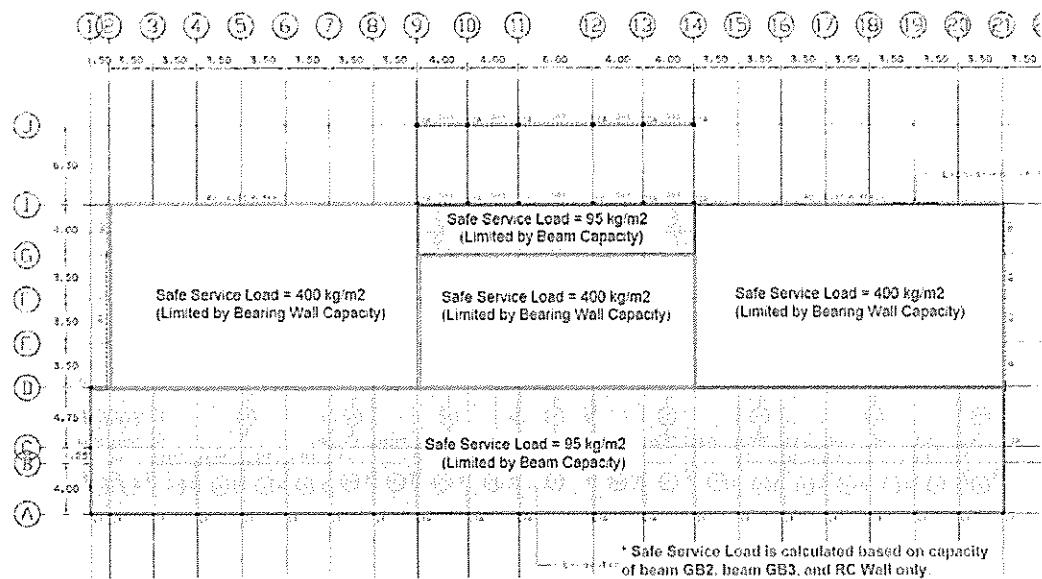
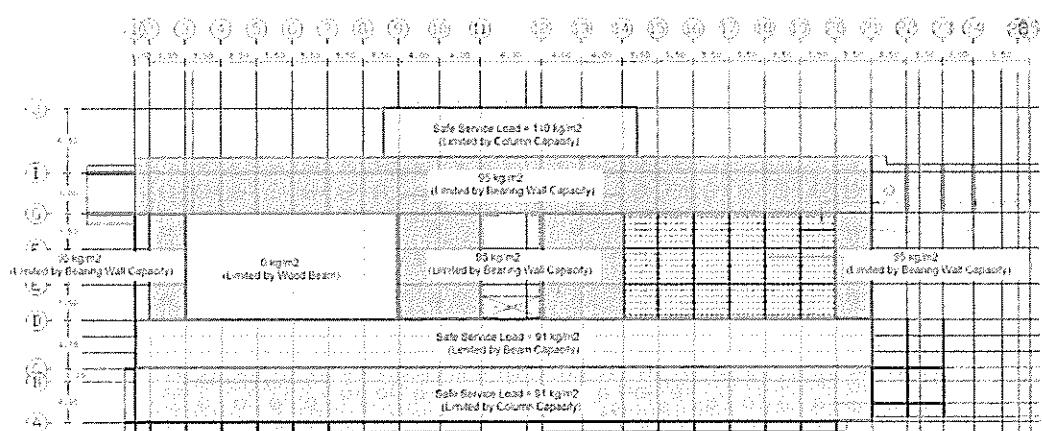
In year 2017, the detail structure stability analysis has been done to evaluate the actual safe service load. The complete 3-dimensional model of the building, shown in Figure 04, was set up. The analysis was carried out by finite element method using structure program “SAP2000”. Base on the structural analysis results, the safe service live load for ground floor and upper floor slab are advised in Figures 05 and 06, respectively.

- A) 2nd floor slab in the middle of the building is timber structure (D-G/3-9 and D-G/14-20). Safe service load of these areas are very low. It is recommended to stop using these areas and do not use as stock area.

- B) Safe service load on terrace of 2nd floor (A-D/1-21) area are quite low (~ 100 kg./ sq.m.). It is strongly recommended to control amount of people to use this area (especially on horse racing time) not more than the recommended service load as above.

- C) Safe service load of 2nd floor, D-G/9-11 and D-G/12-14 area are quite low (~ 100 kg./ sq.m.). It is strongly recommended to control amount of people to use this area not more than the recommended service load as above.

- D) Safe service load of 2nd floor I-G/1-21 and D-G/20-21 area are quite low (~ 100 kg./ sq.m.). It is strongly recommended to control amount of people to use this area not more than the recommended service load as above.

- 7.1.3 During the period, waiting for the result on clause 7.1.1, the safe service load on each part of the building **shall be limited as specified in report on year 2017** or as mentioned in Fig 05 and Fig 06.
