THE CLUBHOUSE PROJECT

Introduction

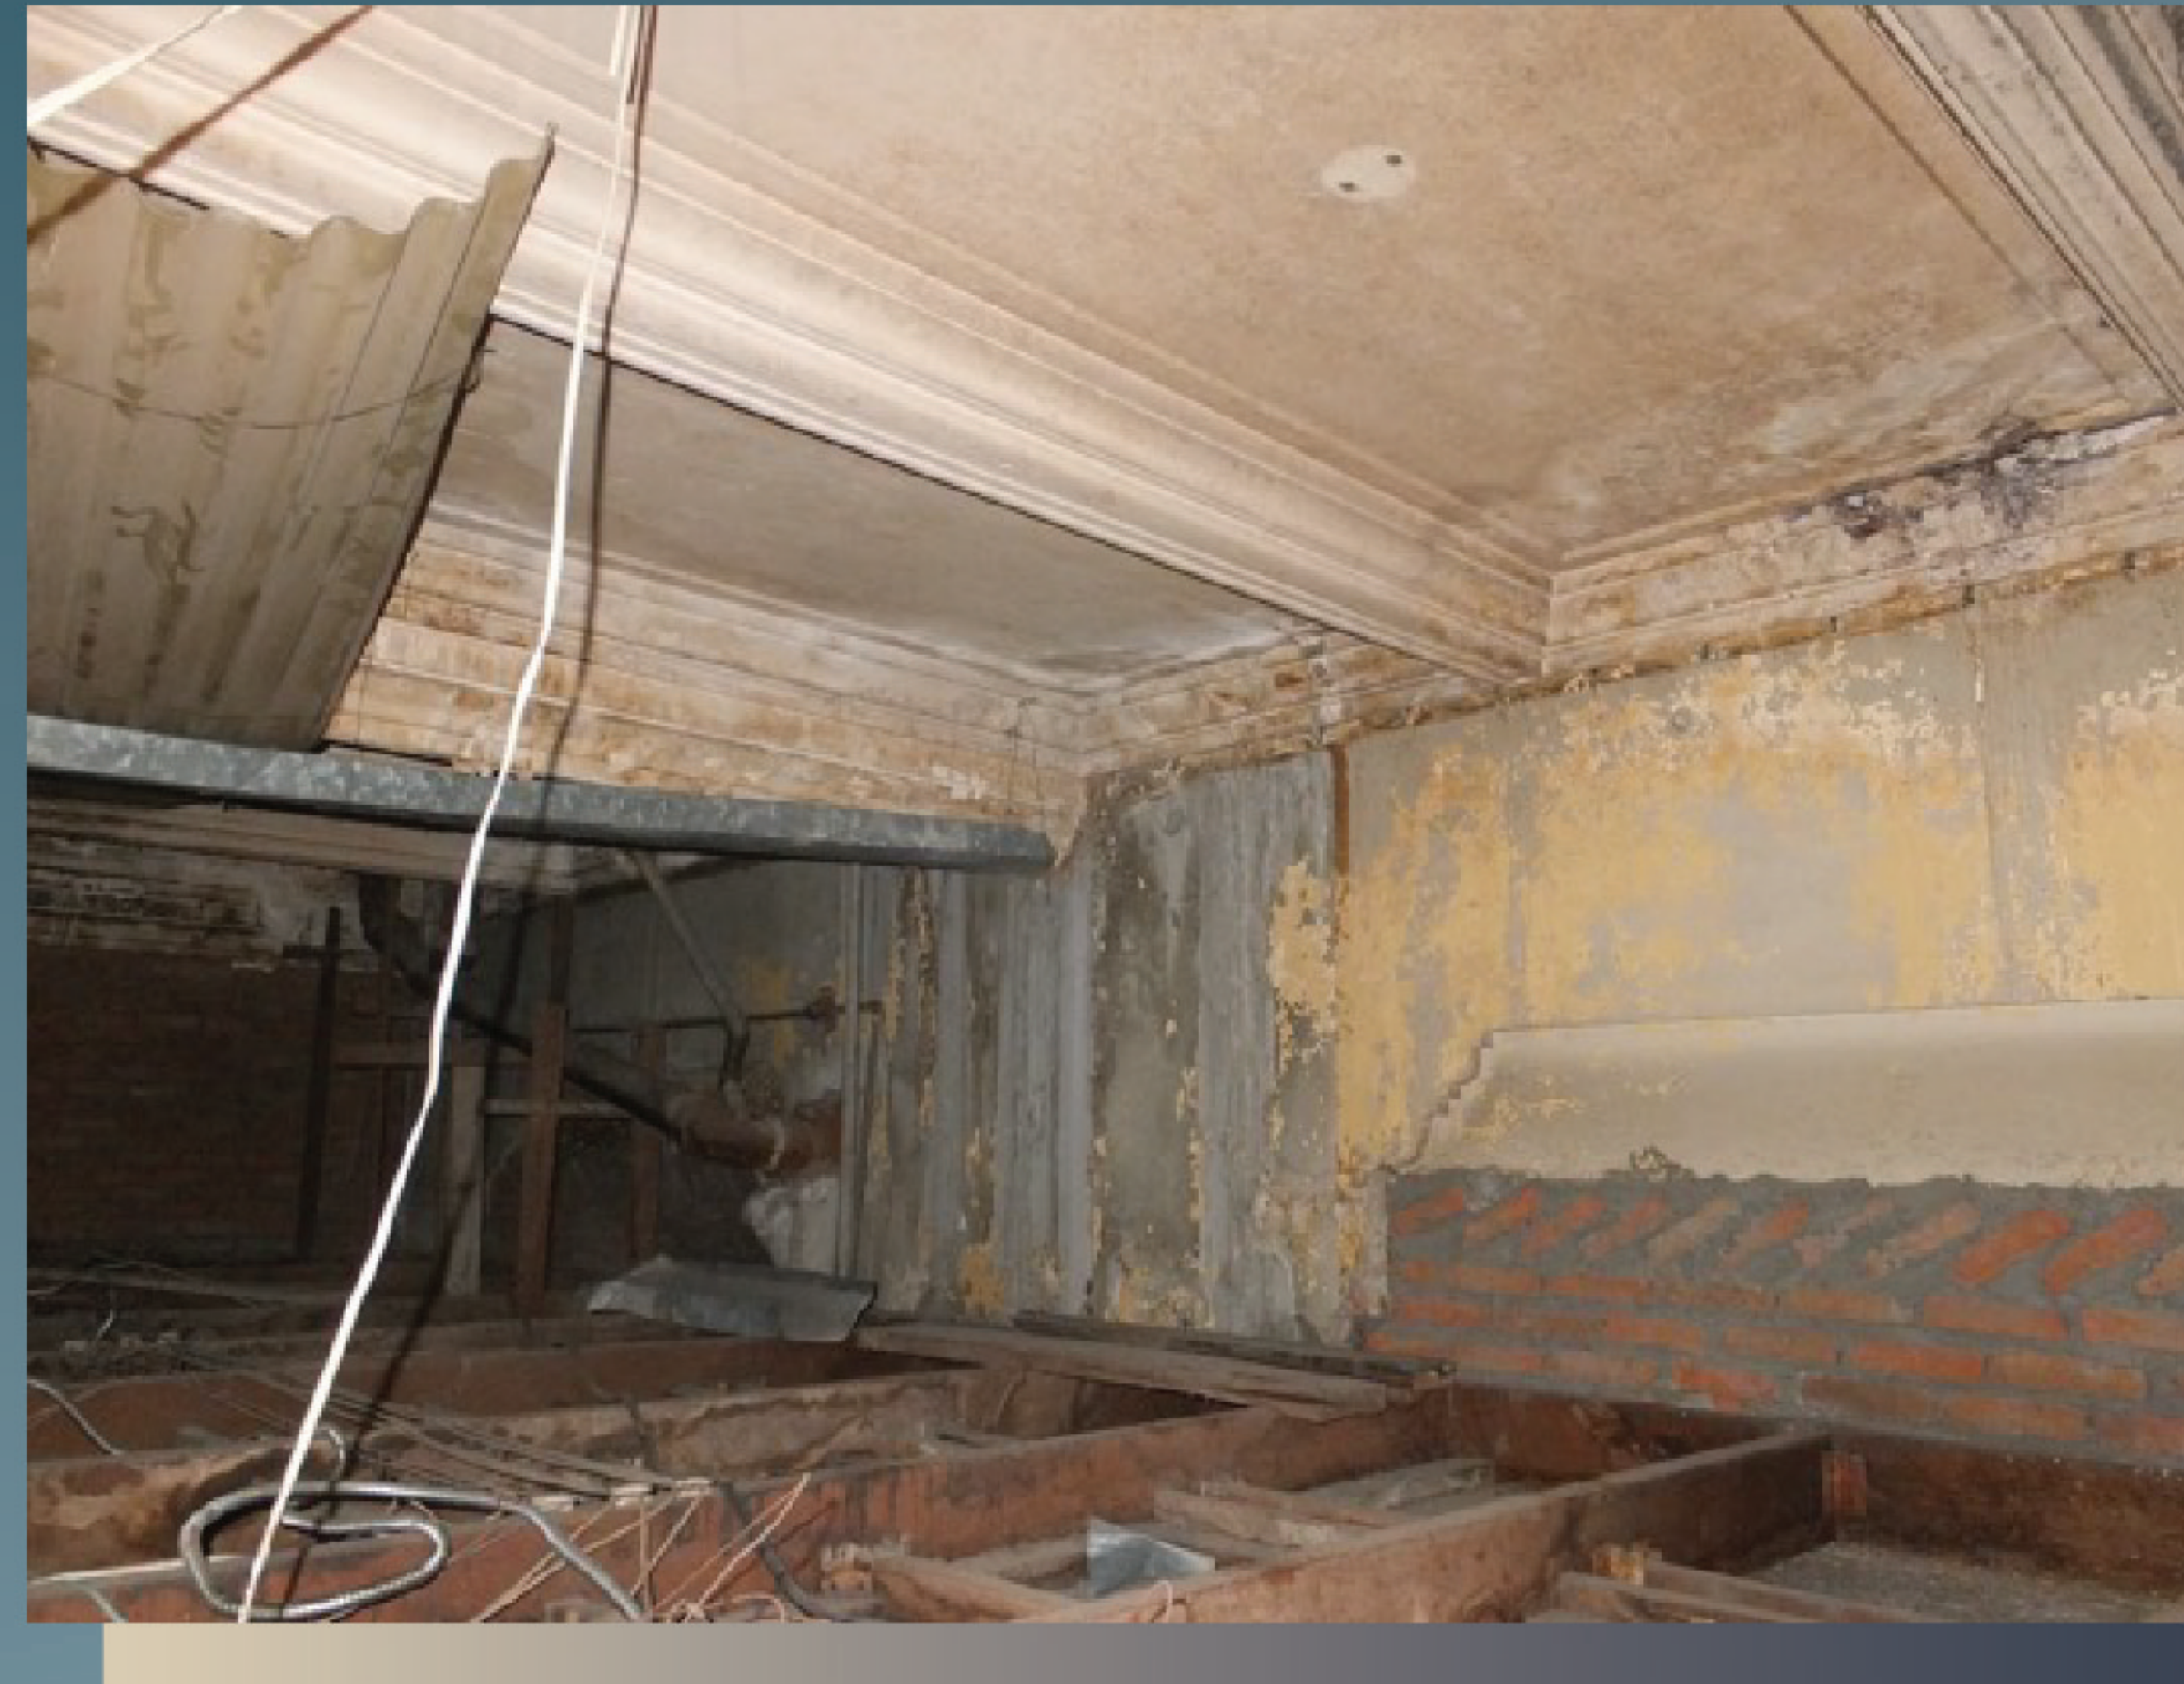
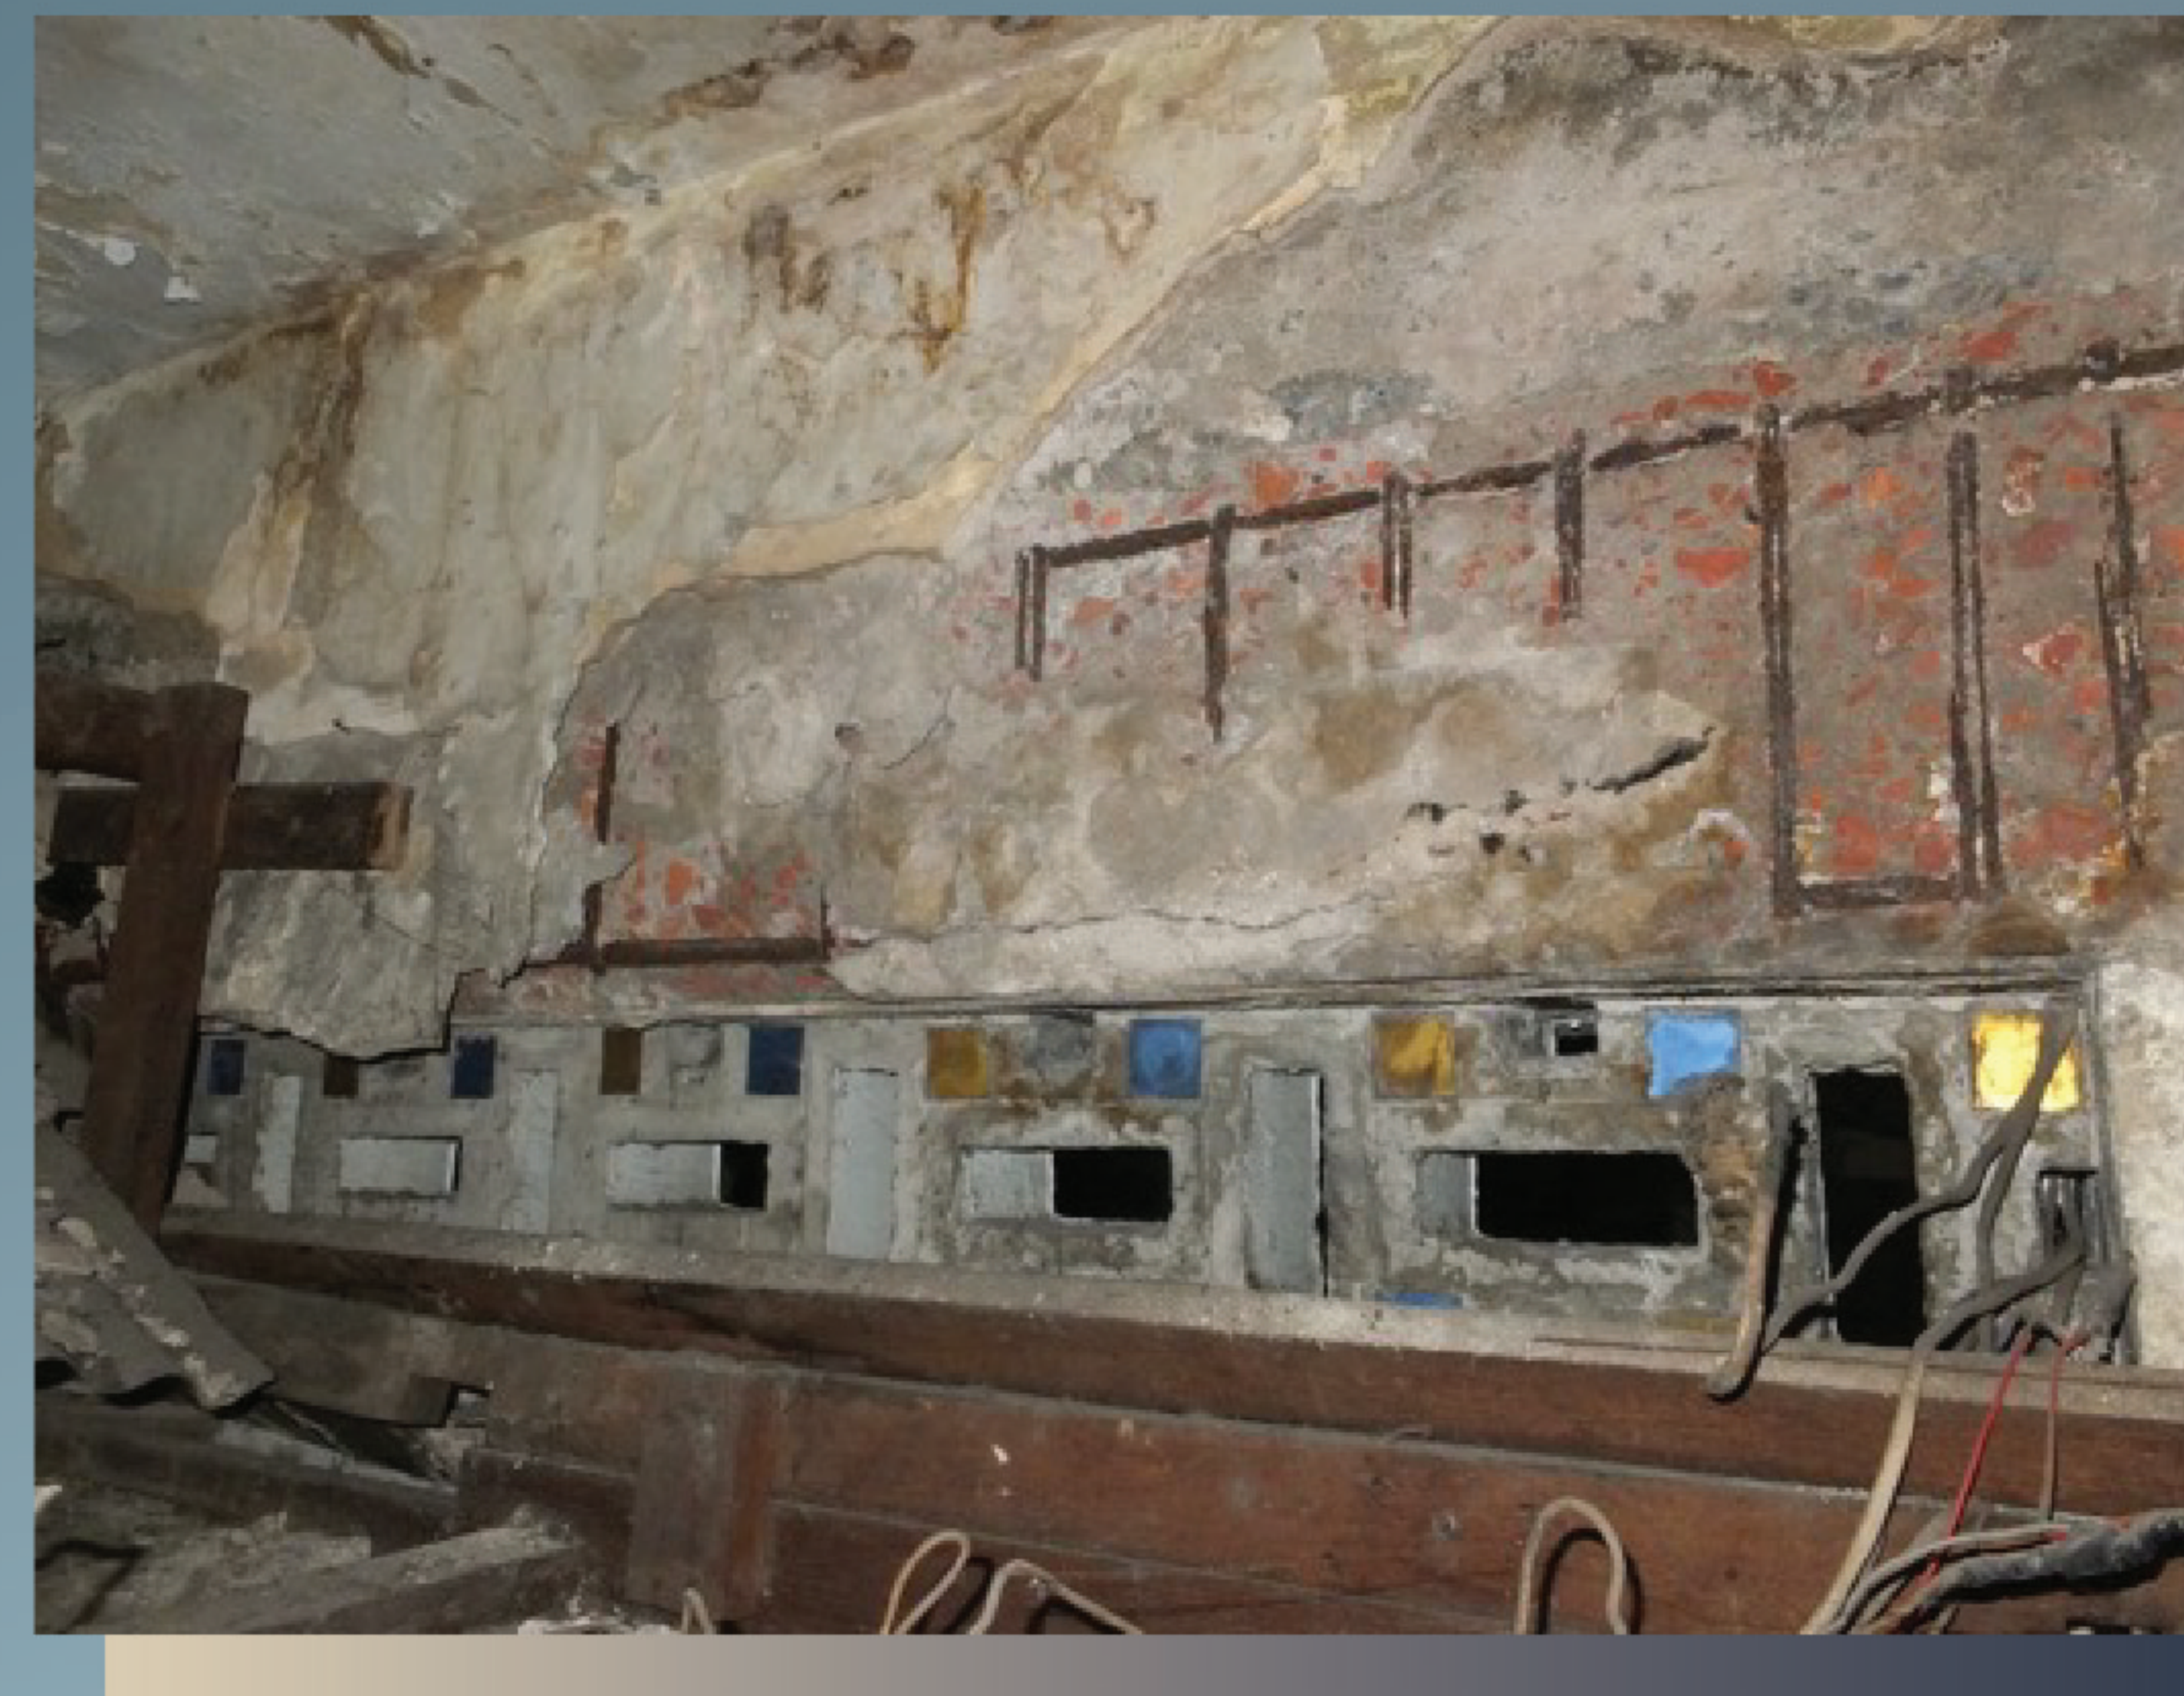
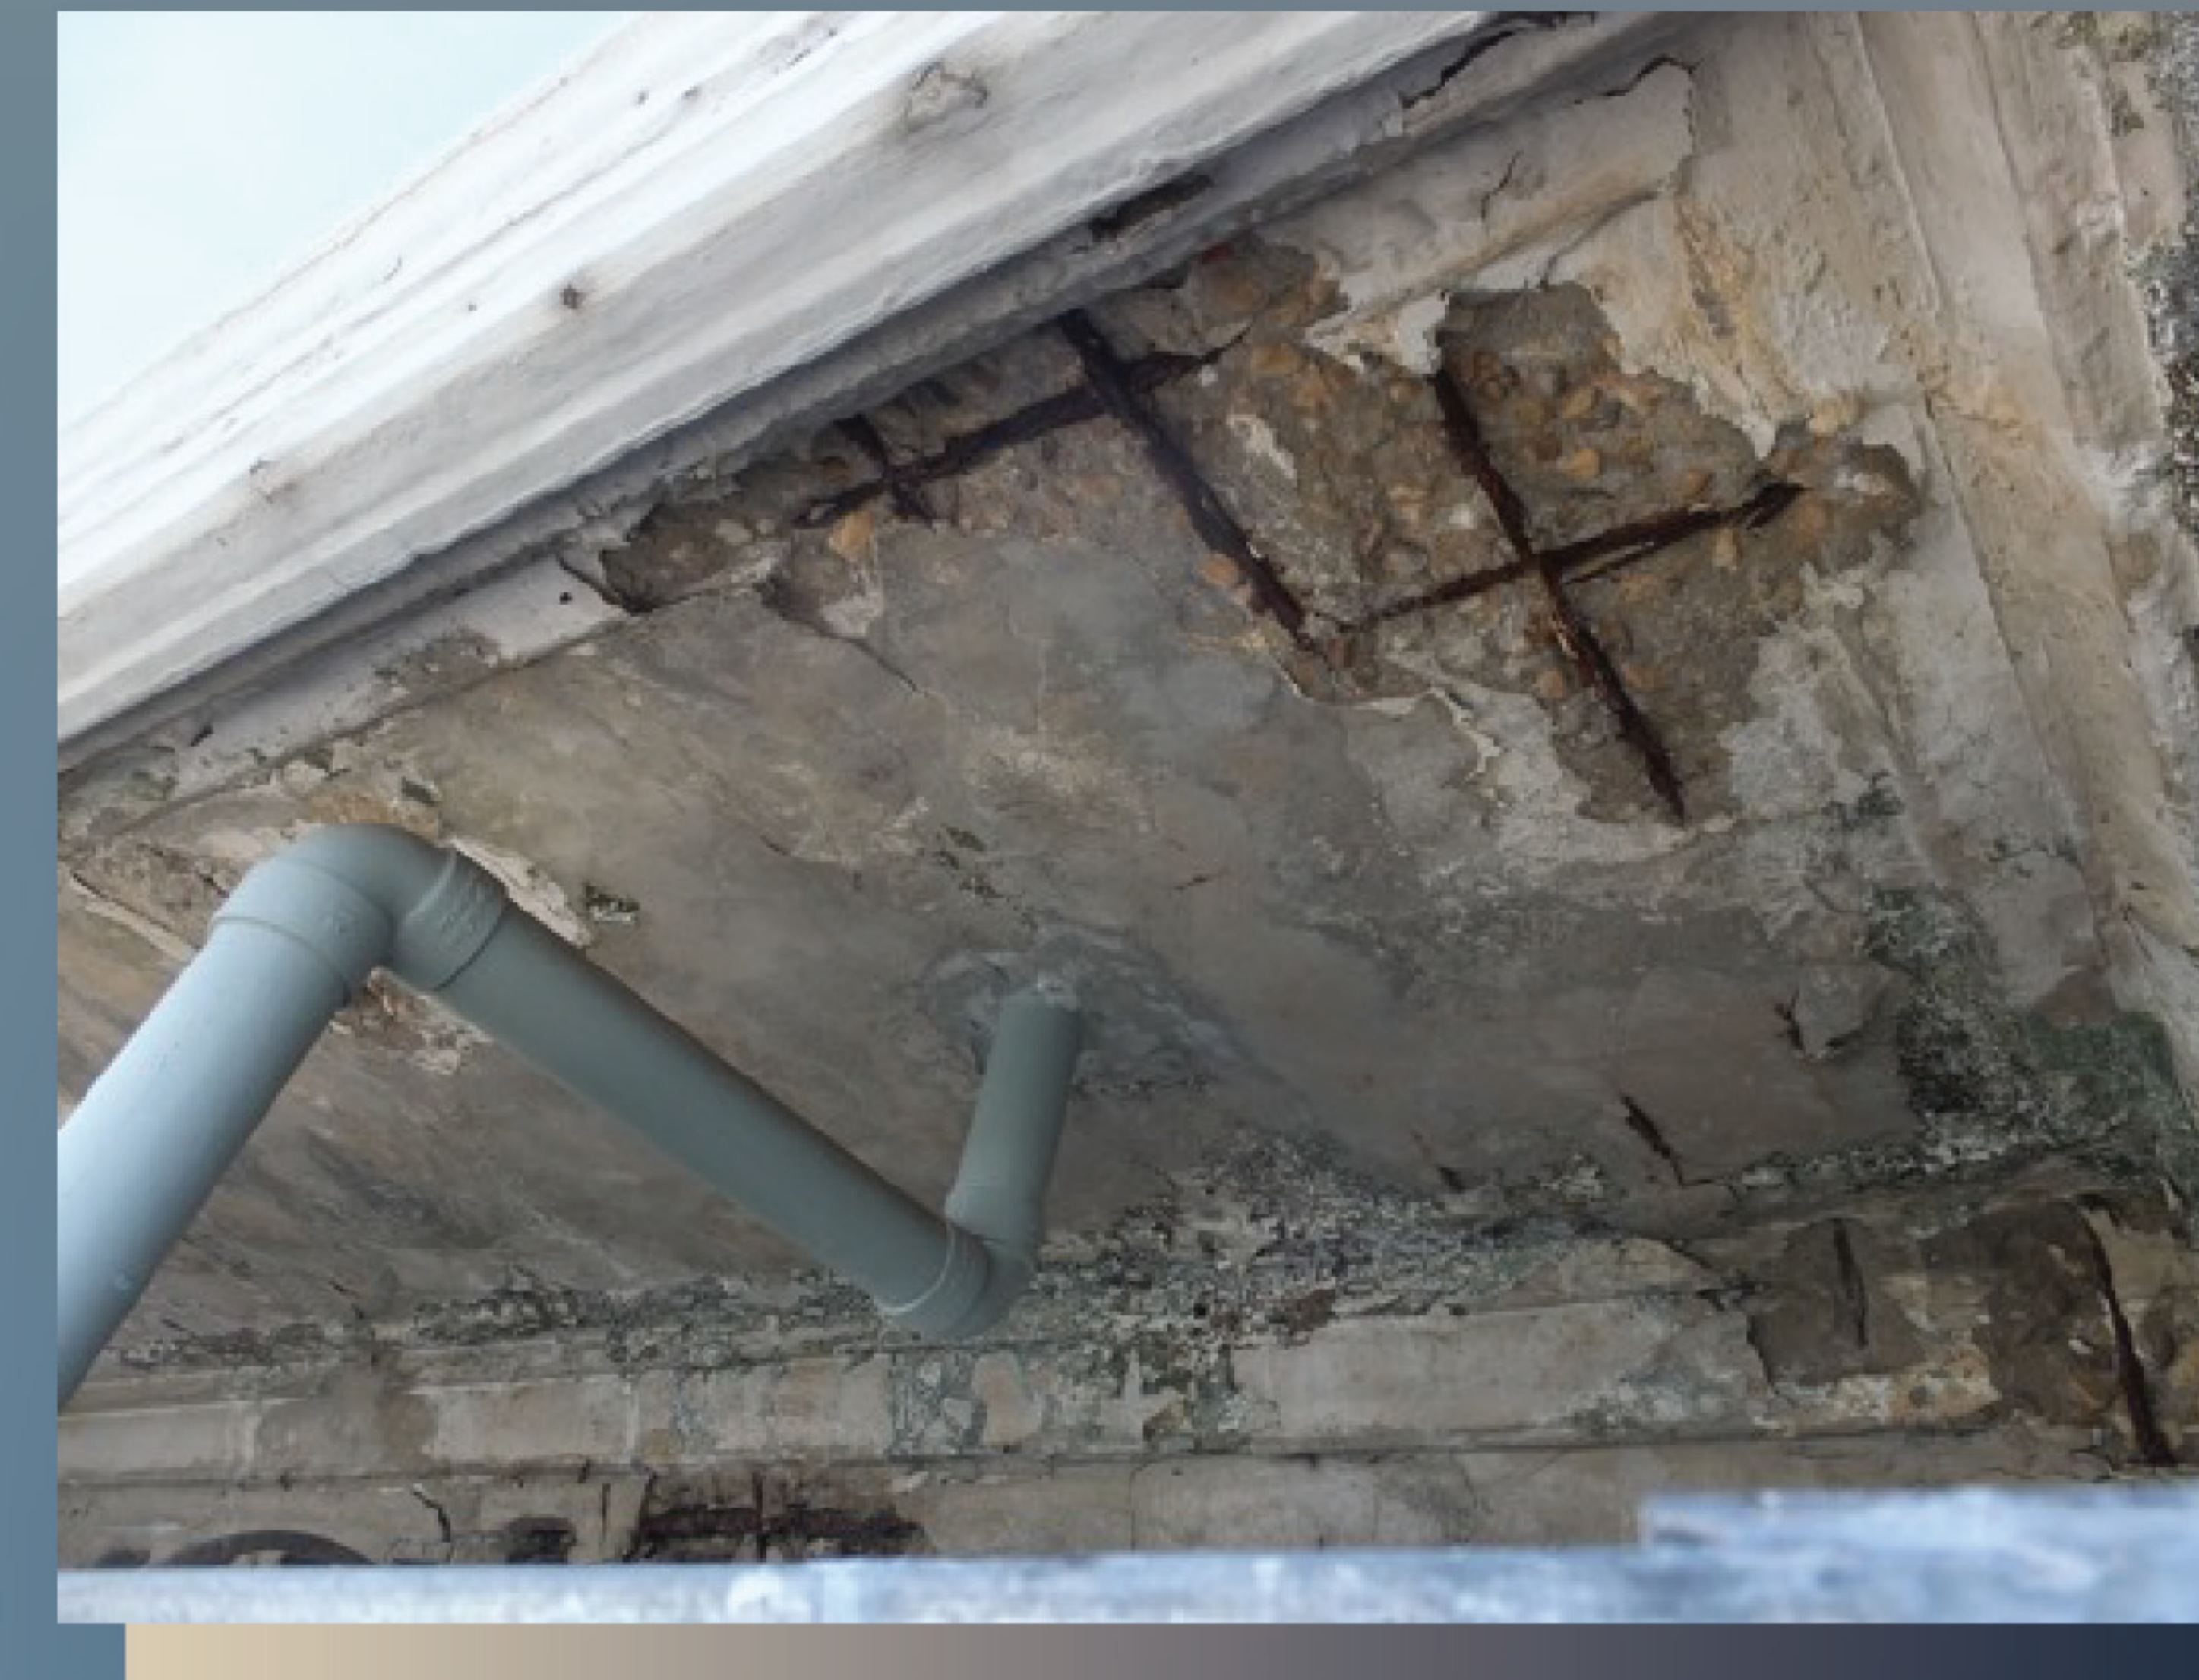
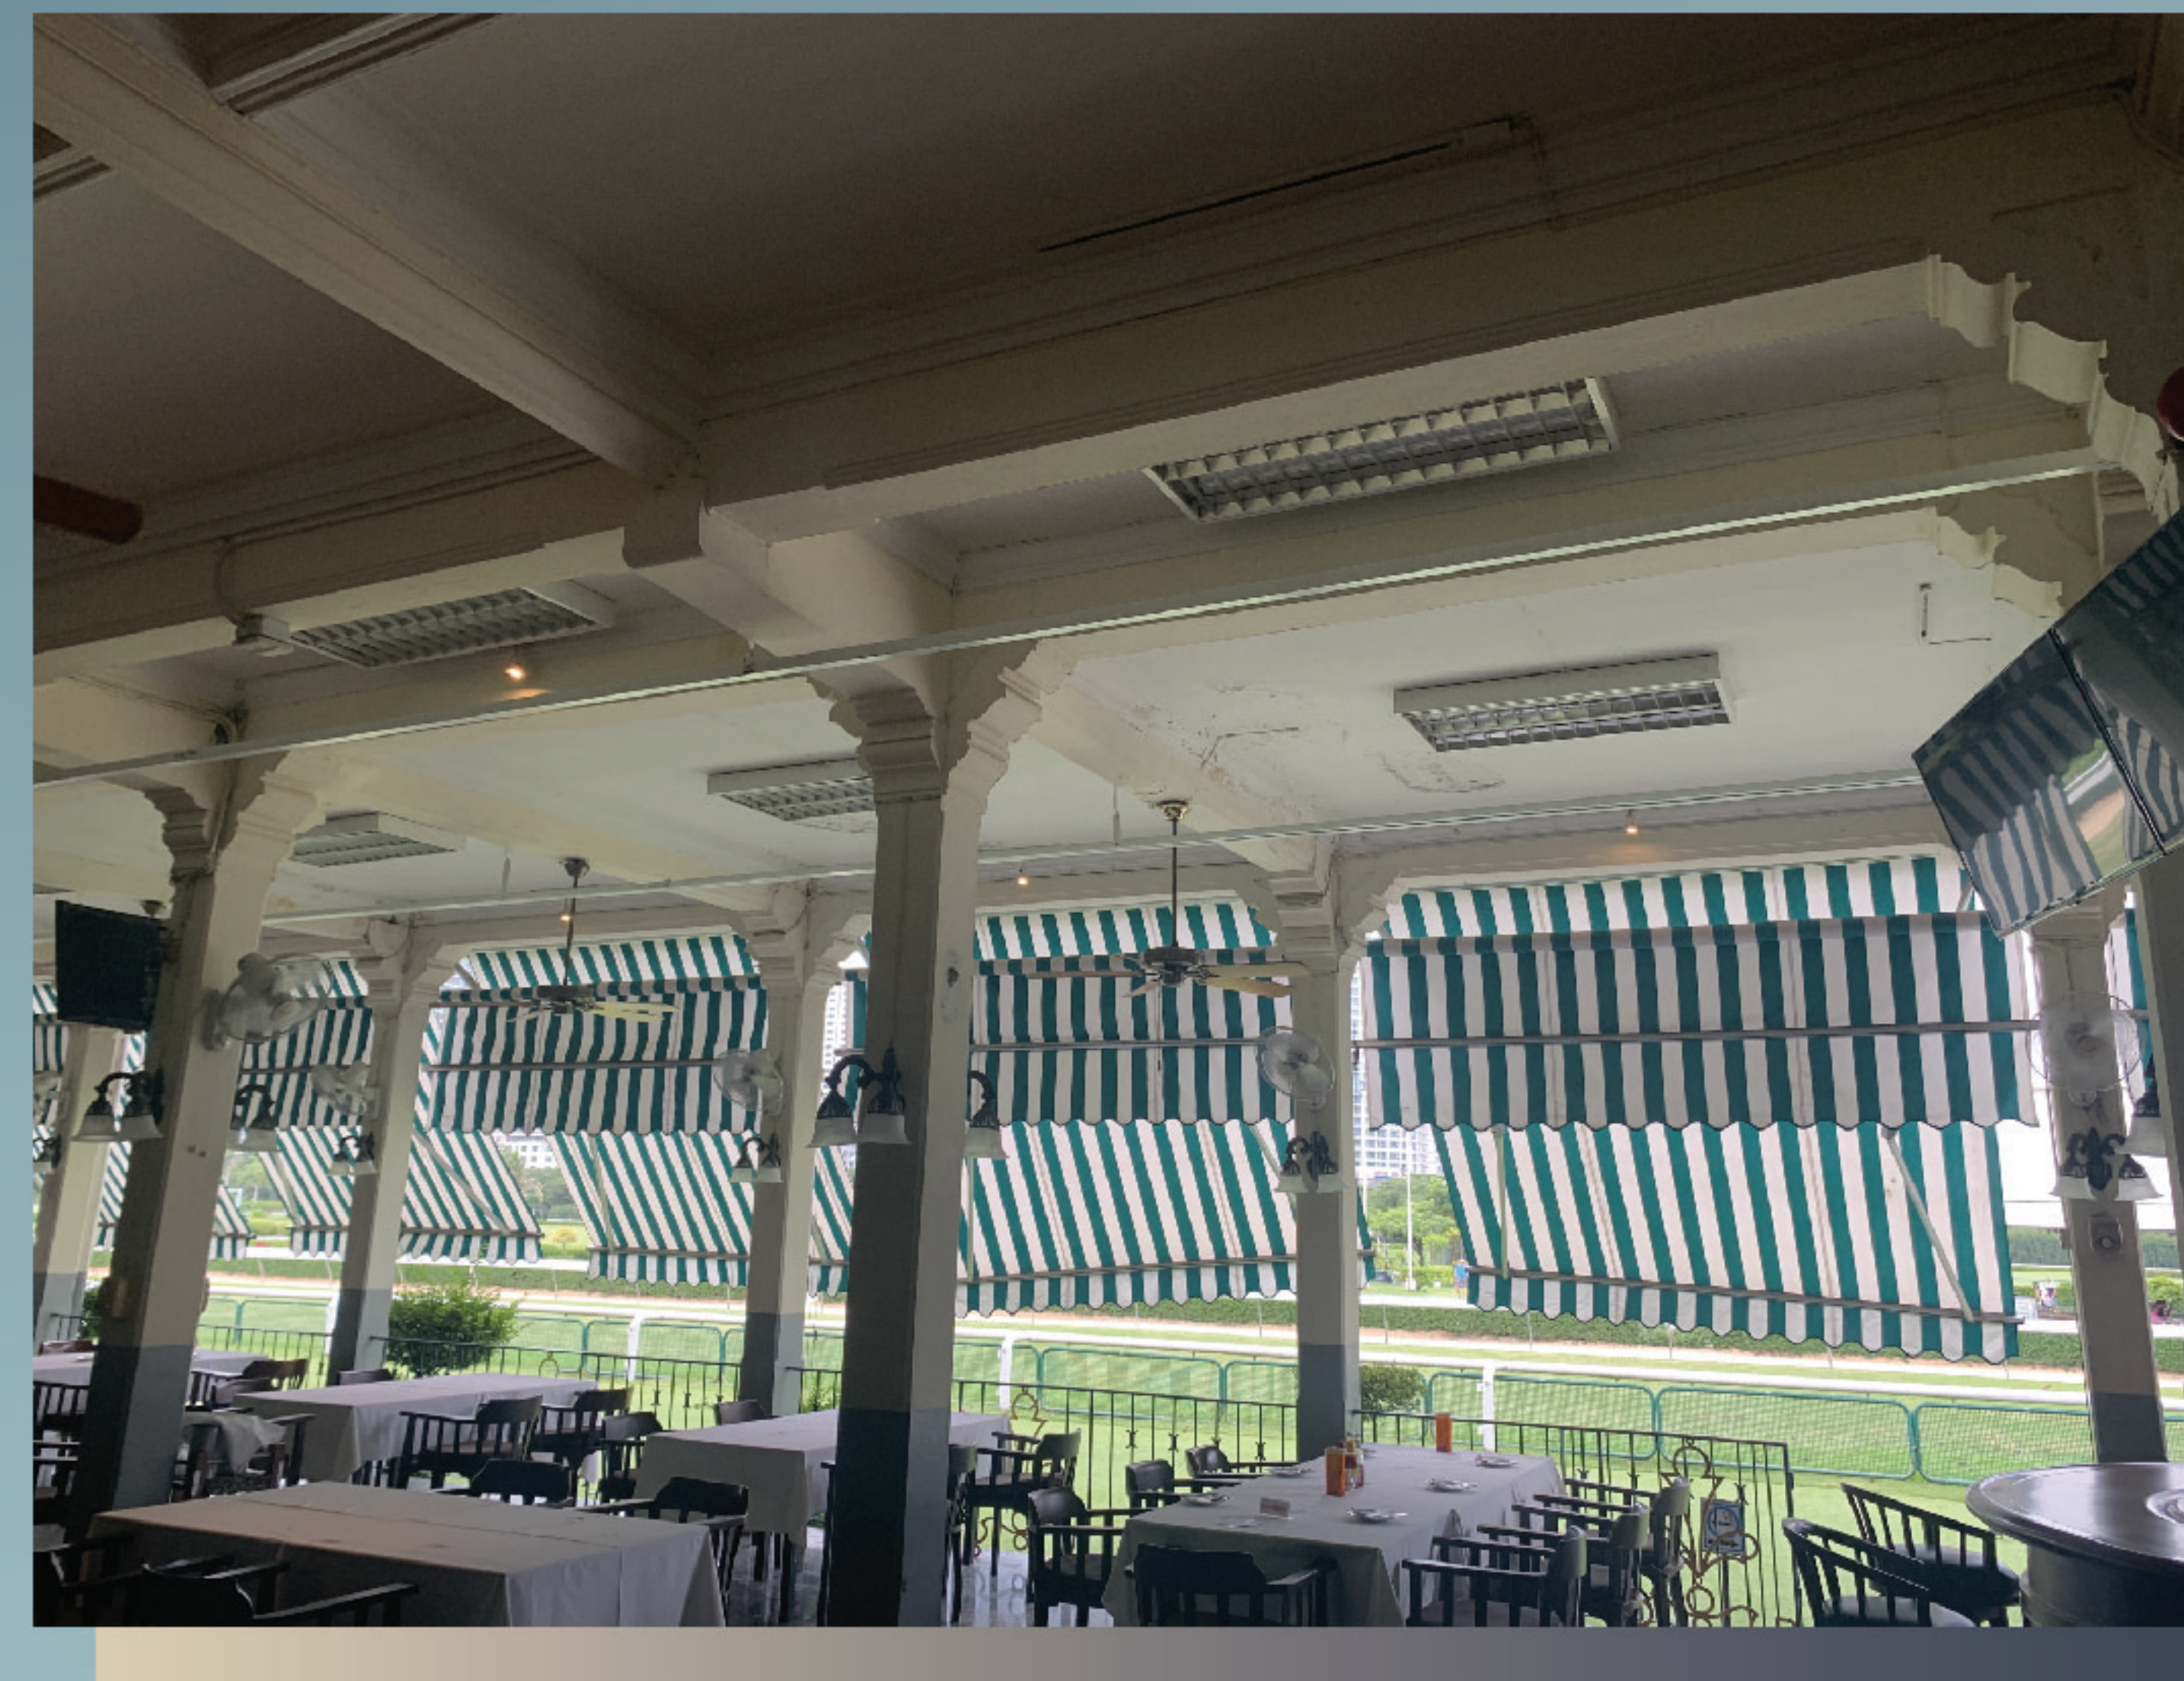
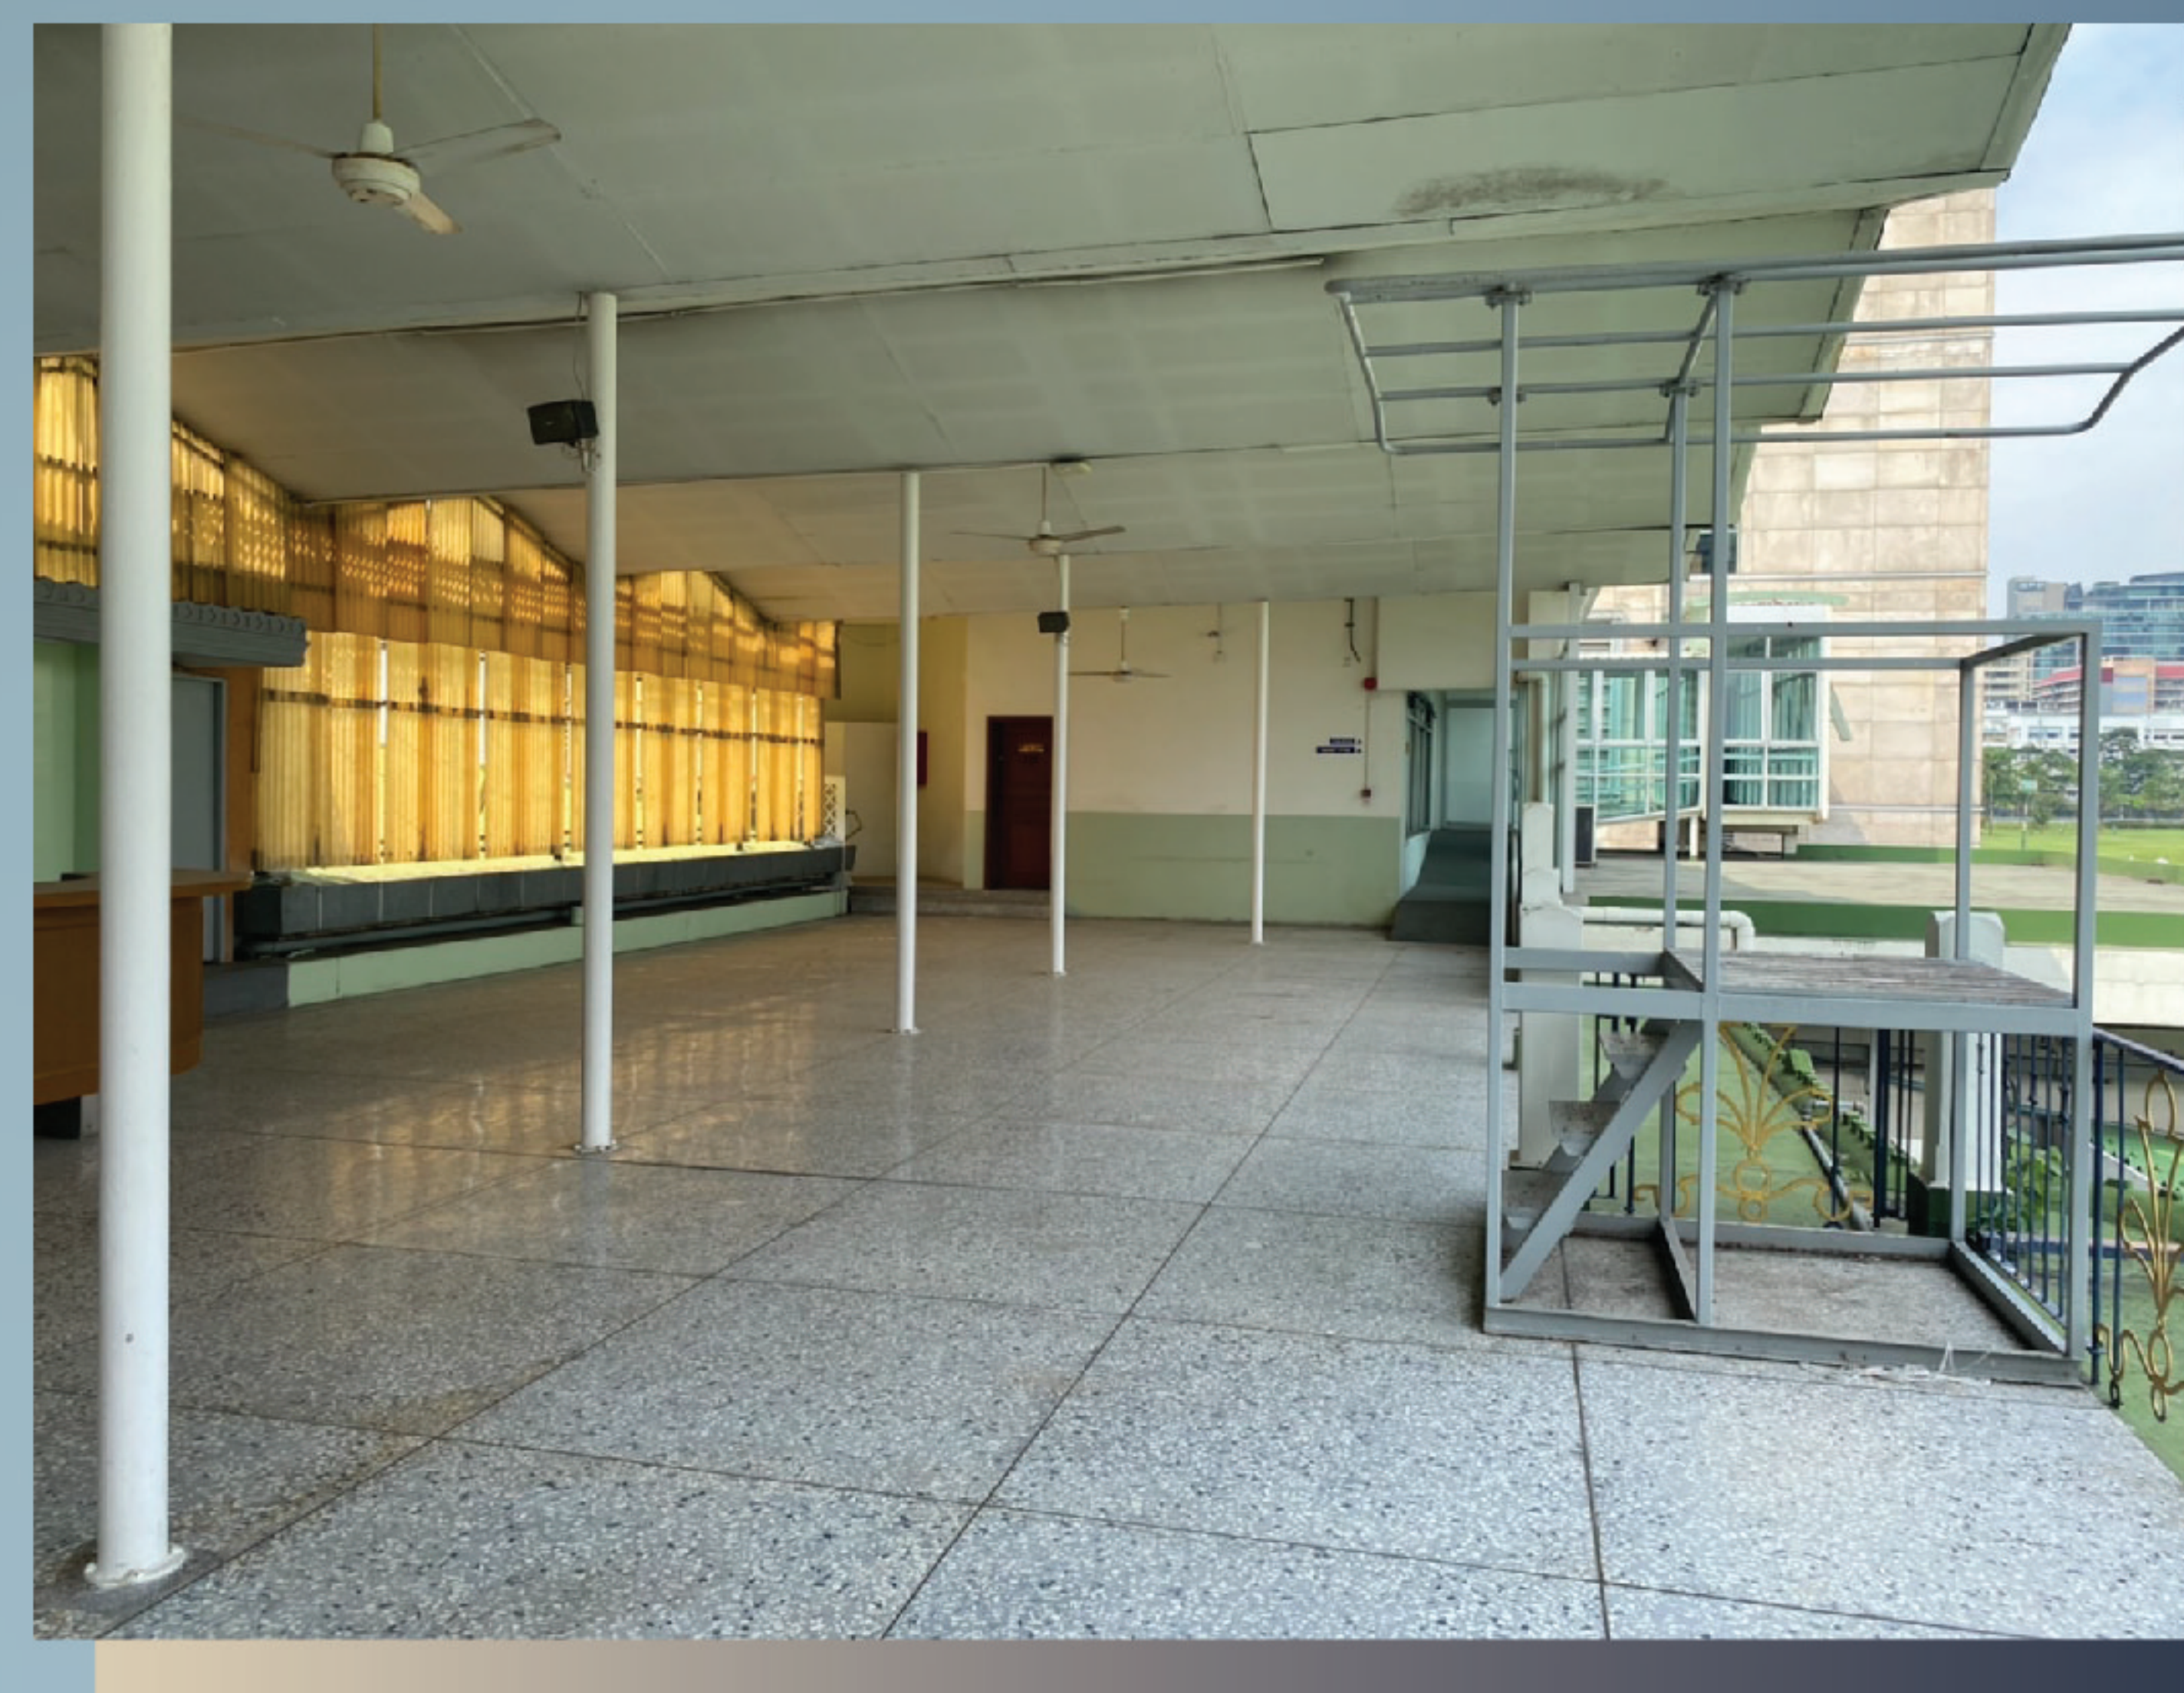
The Old Clubhouse Physical Damage

3. Structural damages reported from engineering visual inspection

The second-floor structure adjacent to the swimming pool area is severely damaged due to exposure to rain and mechanical heavy loading resulting in concrete deterioration and spalling off with reinforcement corrosion. The second-floor structure adjacent to the racing course is found to be moderately damaged with signs of concrete deterioration and reinforcement corrosion. The other areas underneath the roof shelter are found to have numerous water leakages.
