THE CLUBHOUSE PROJECT

Introduction

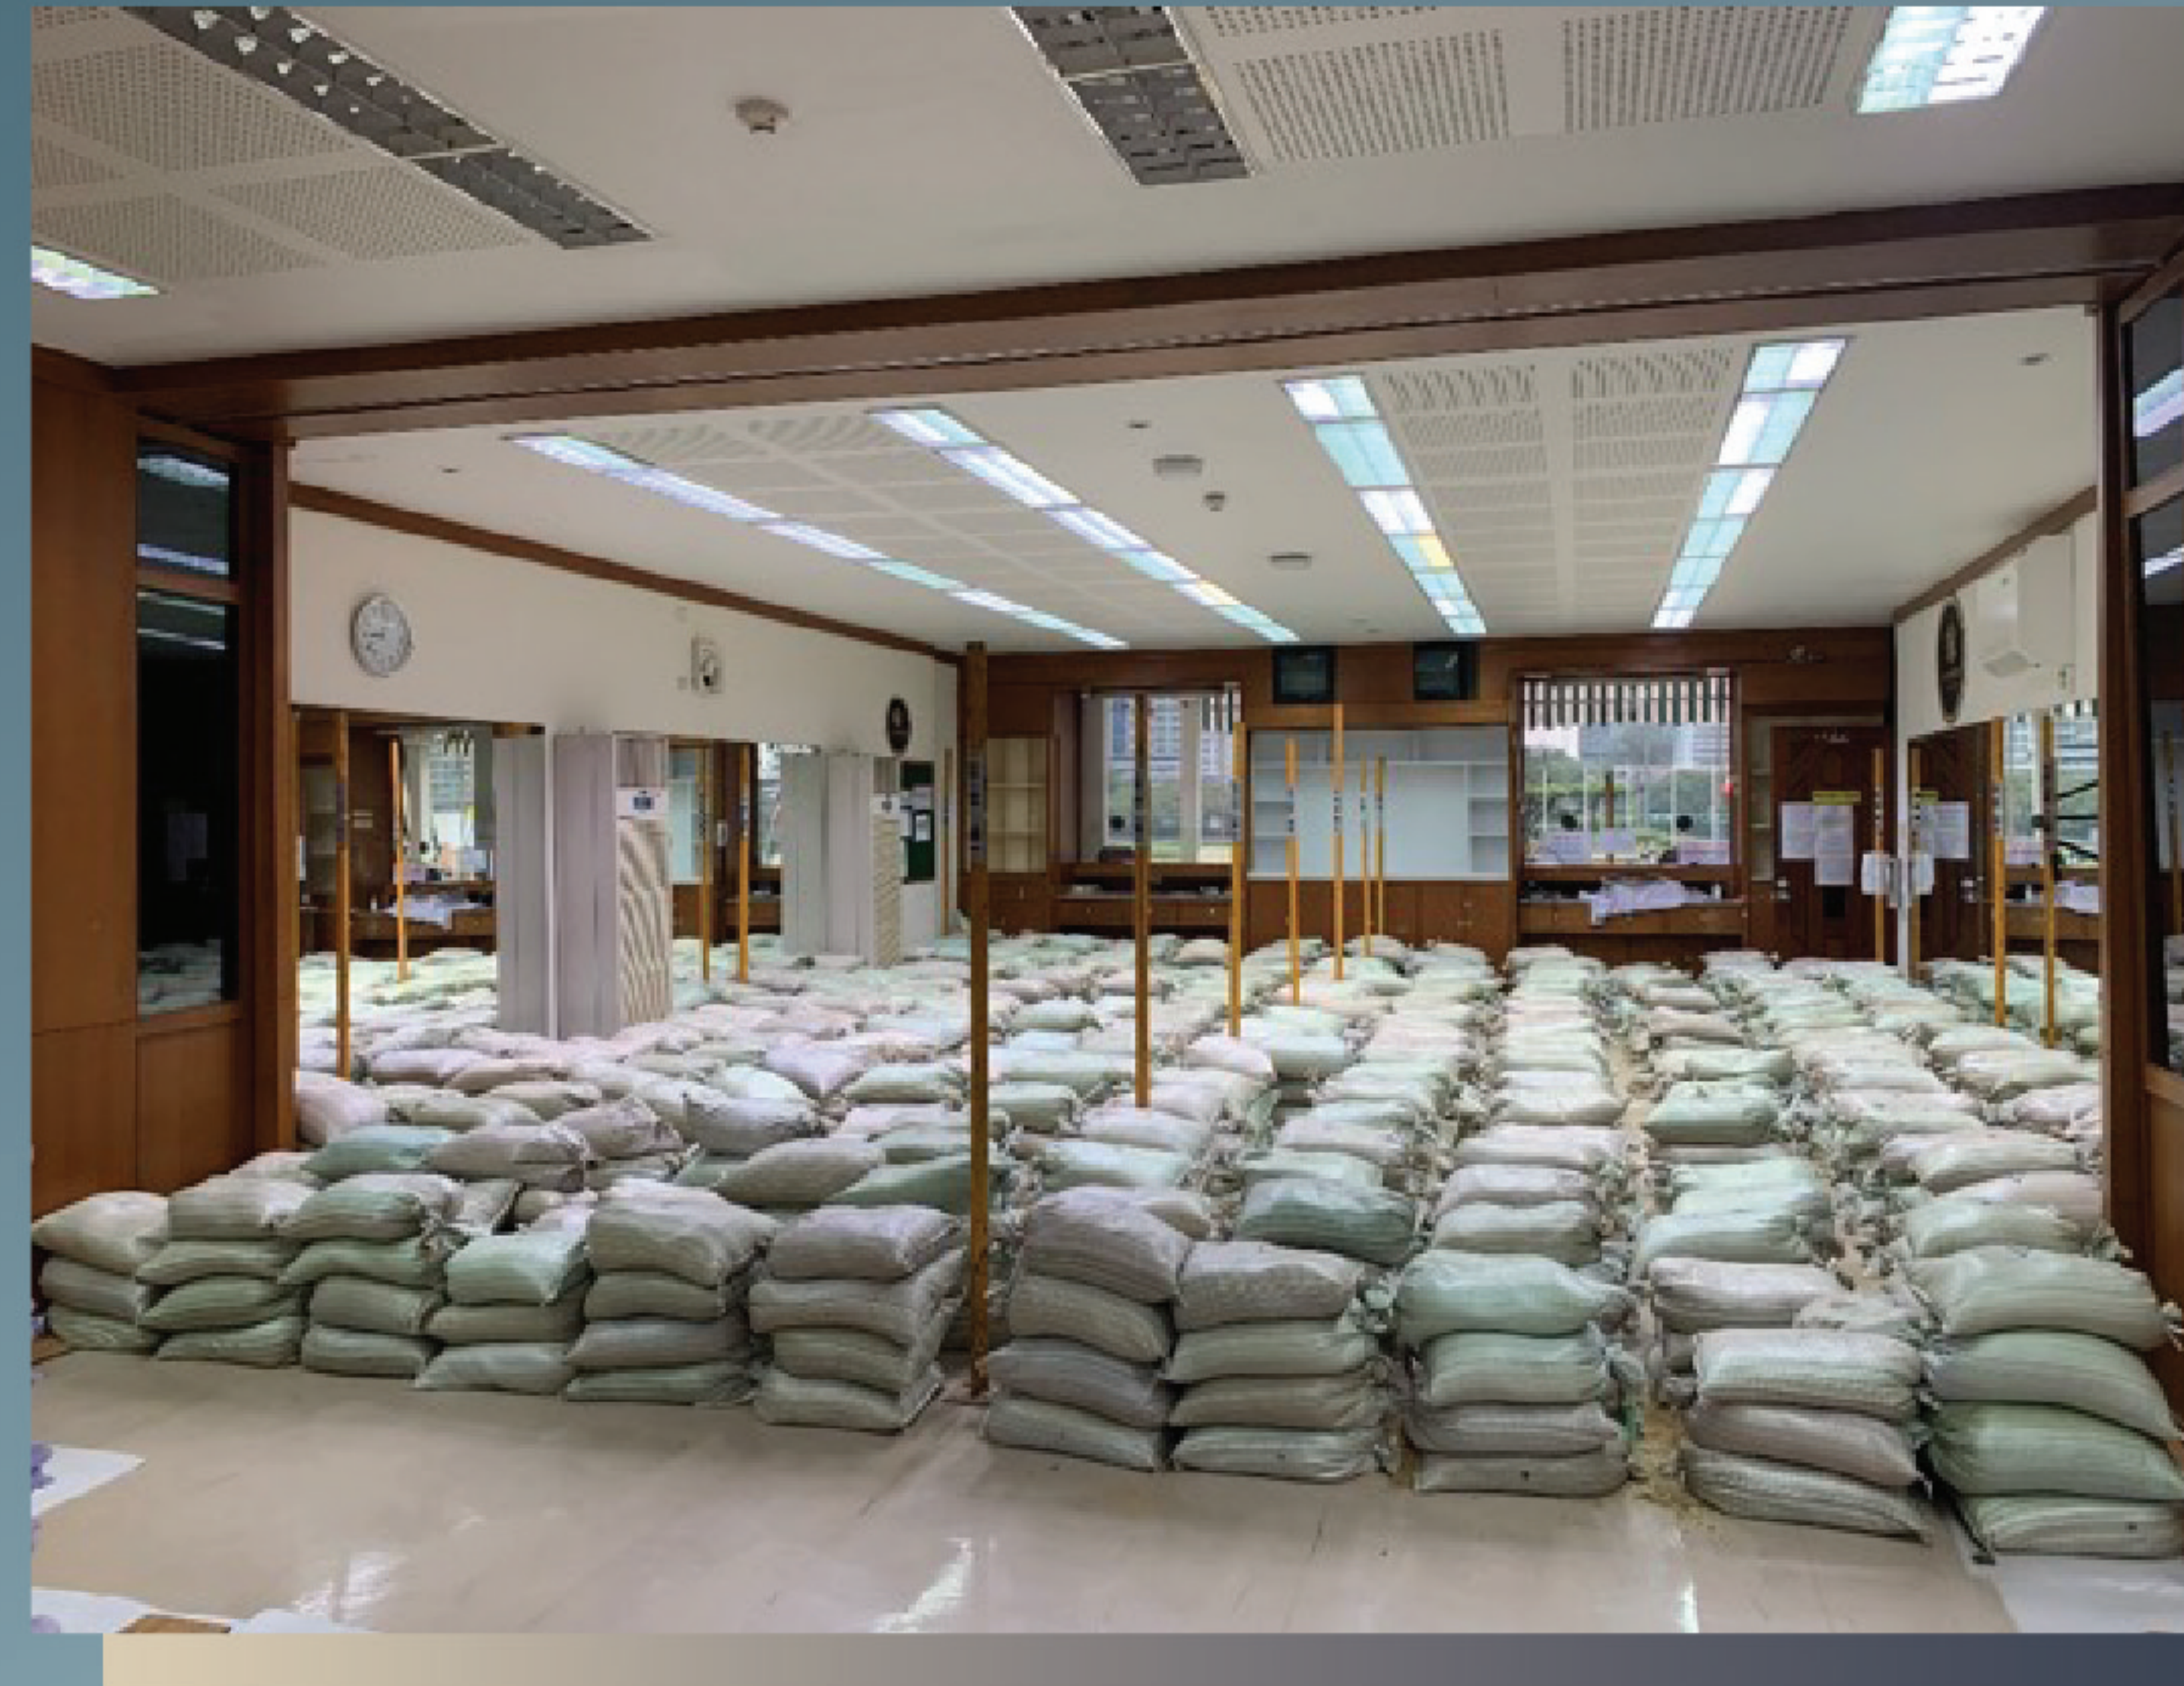
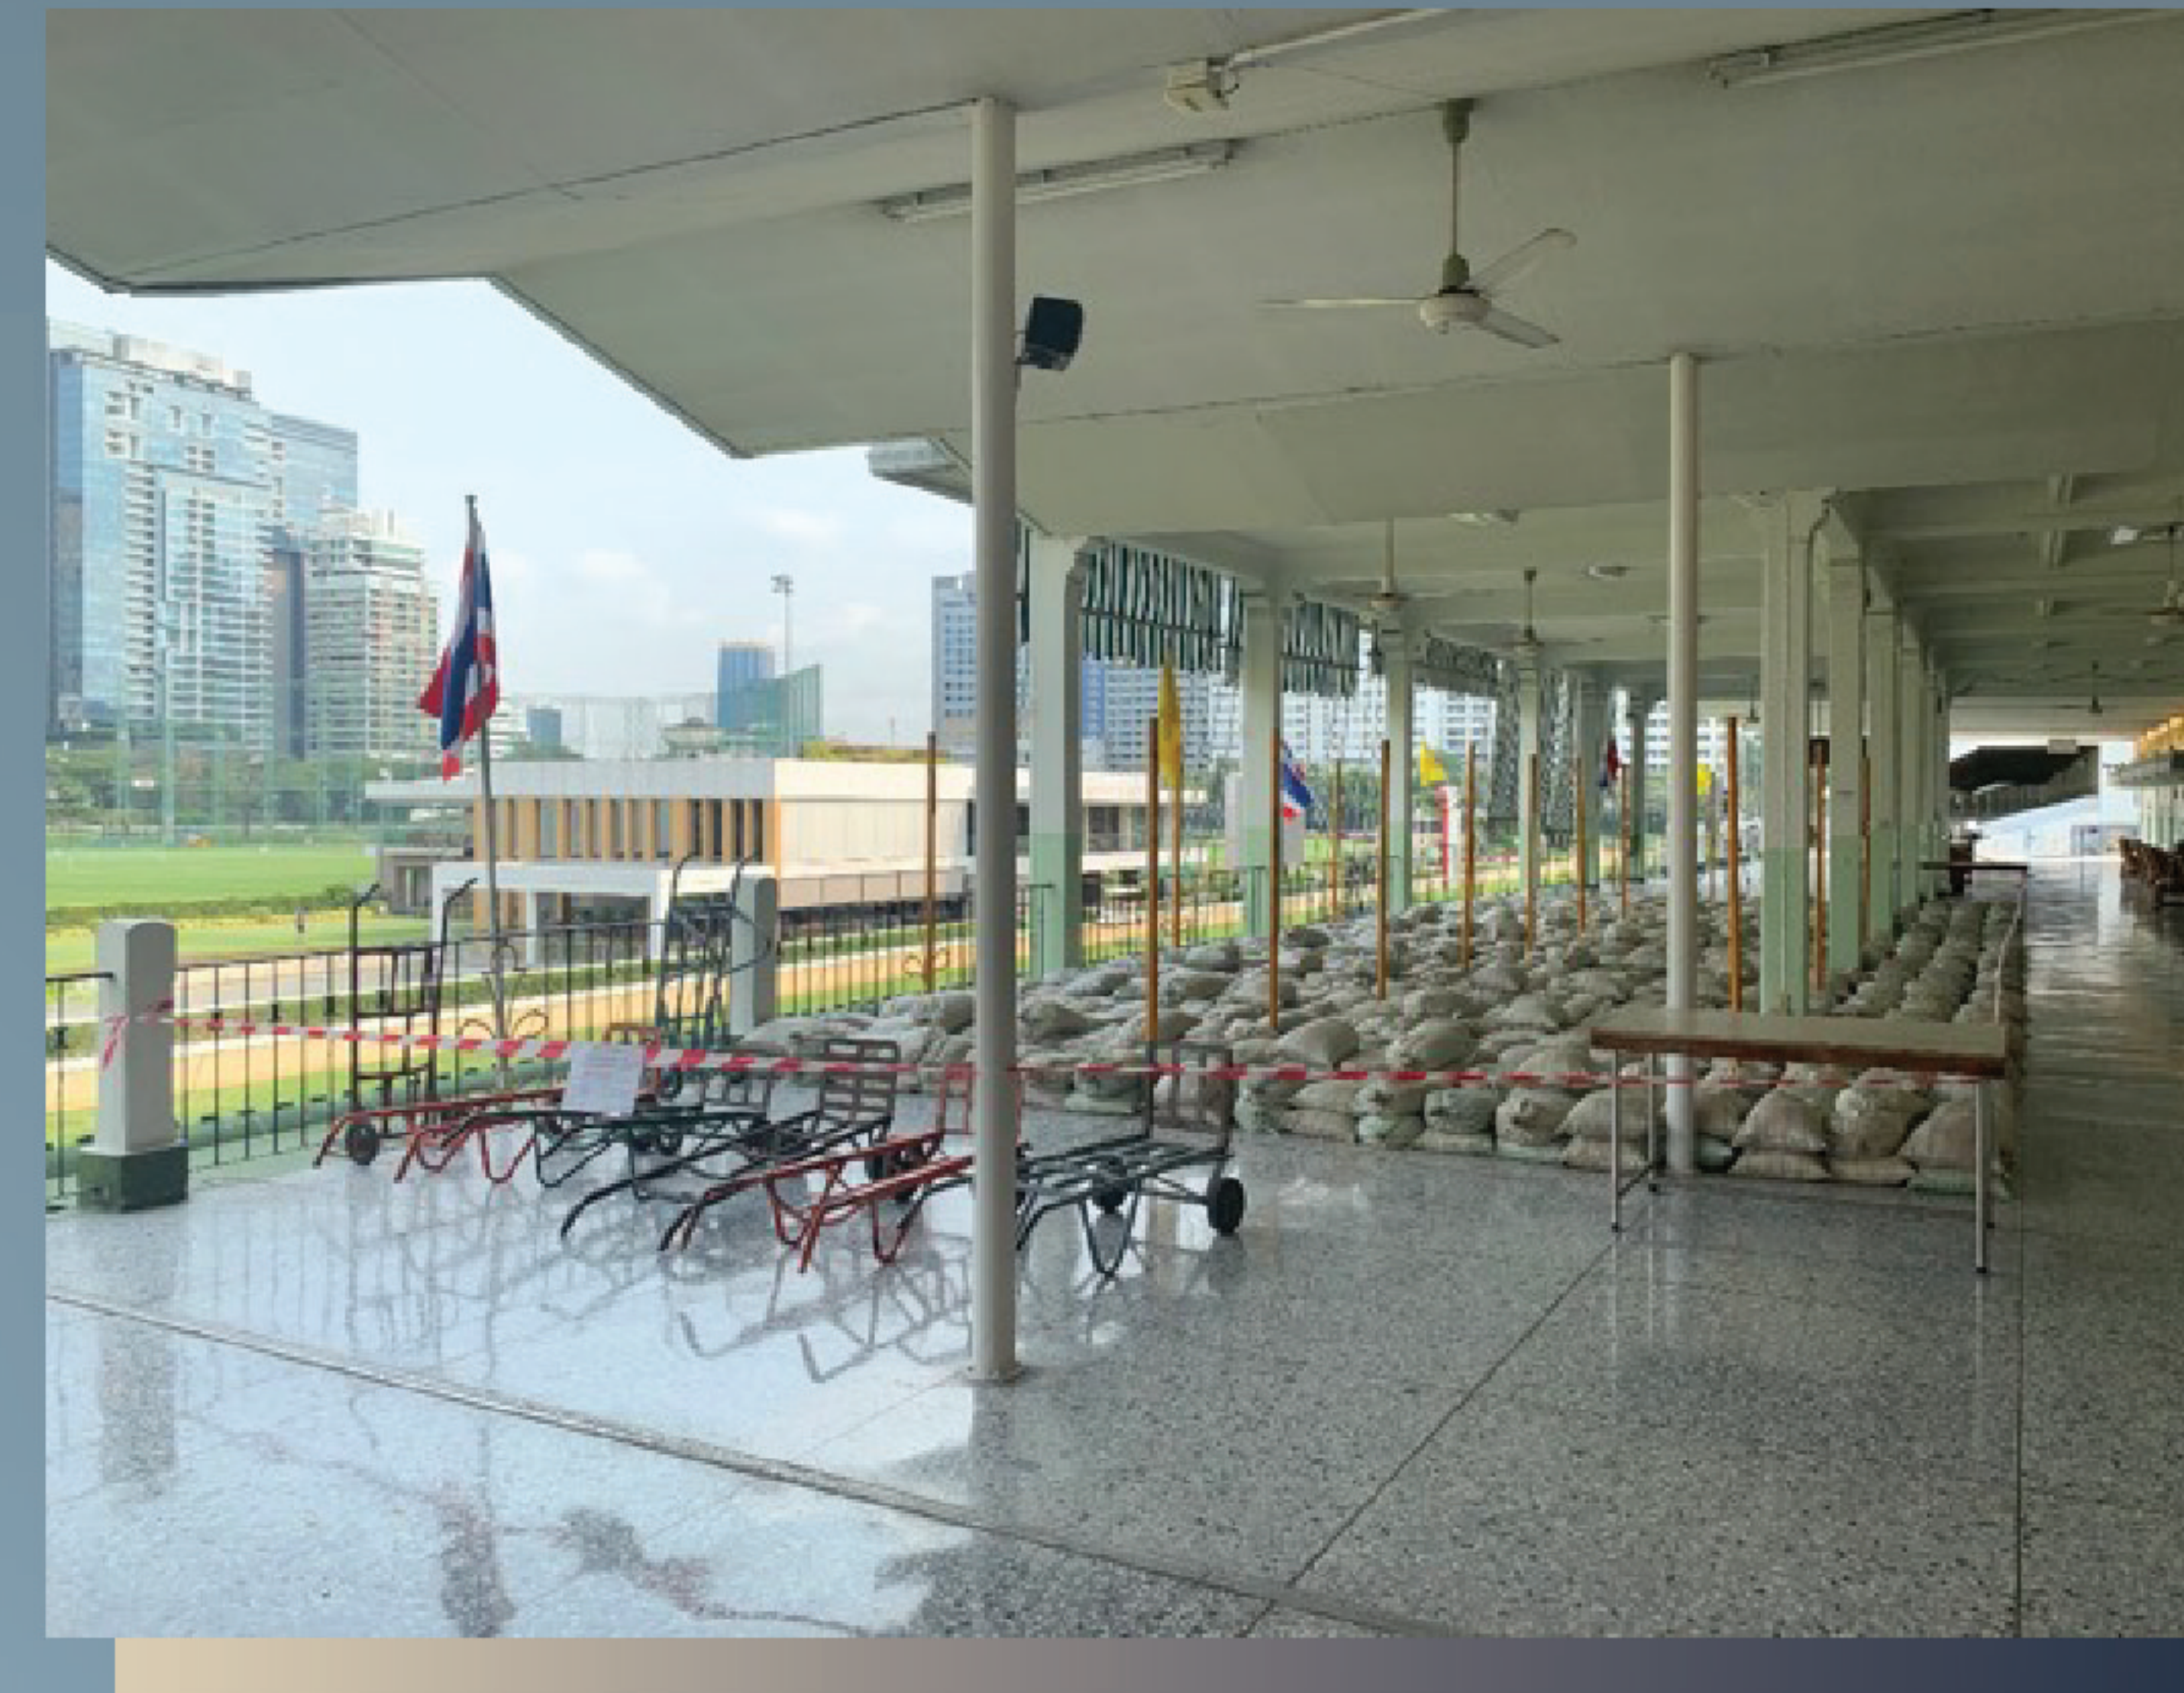
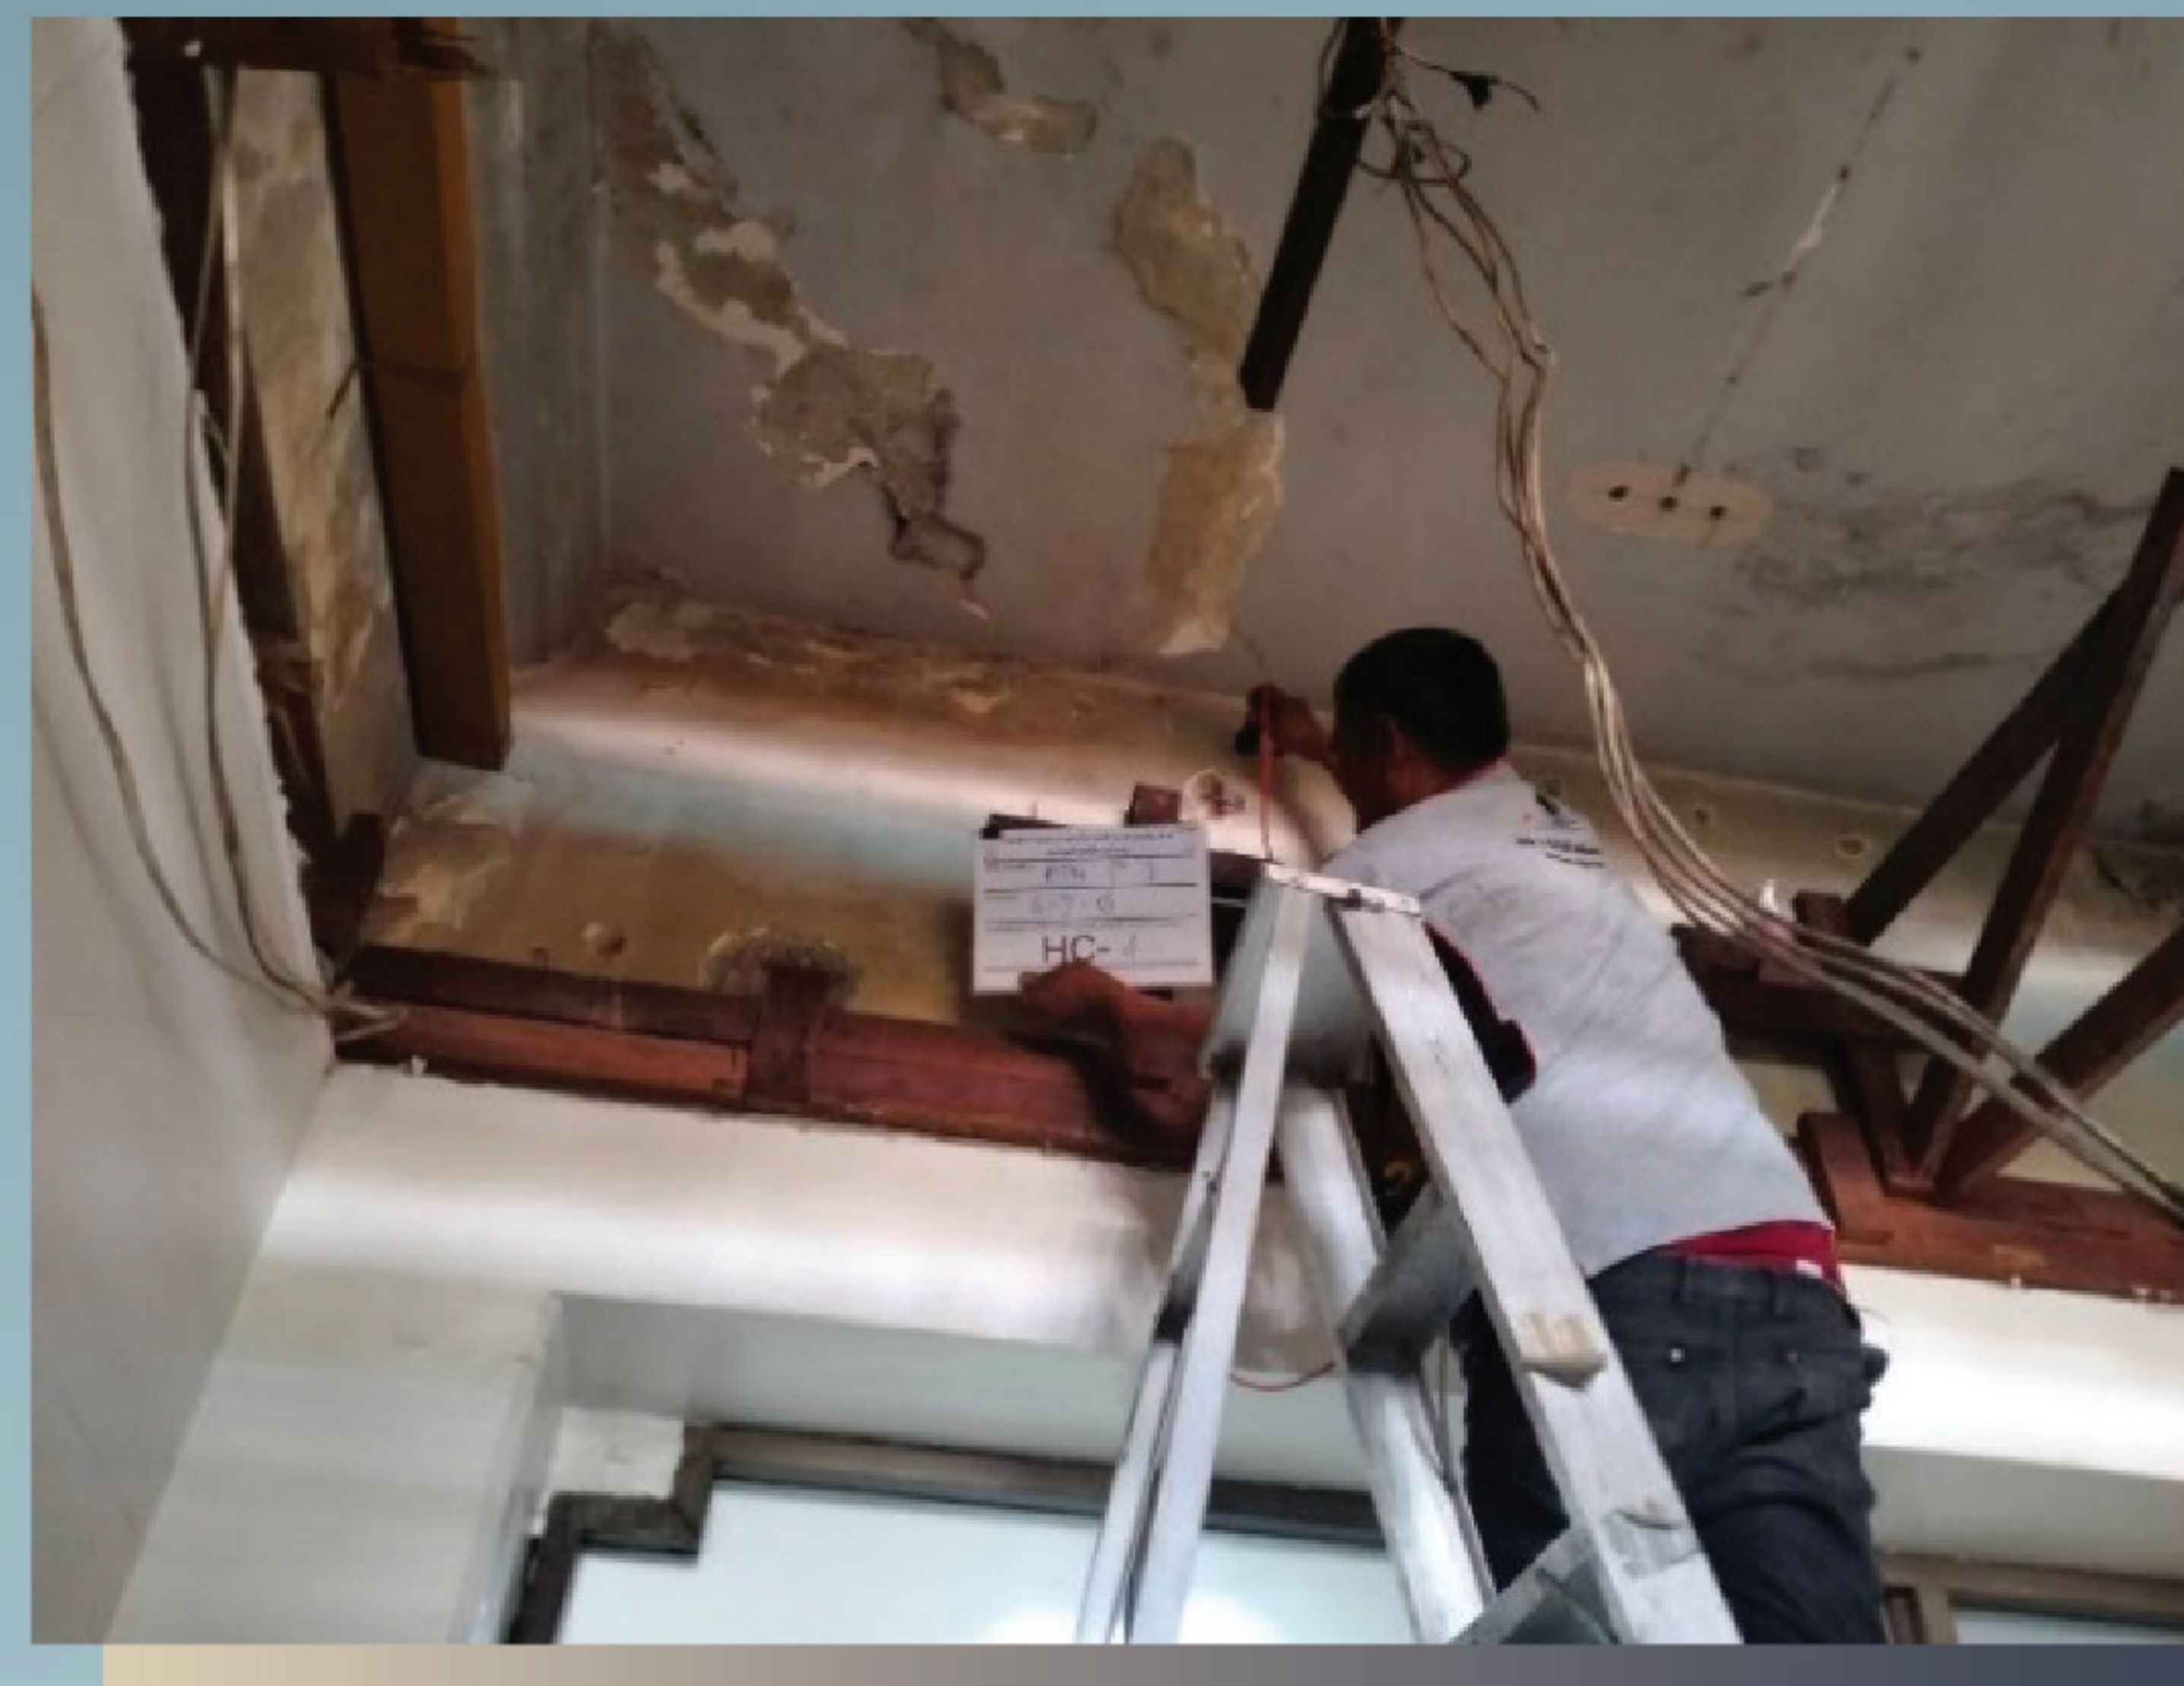
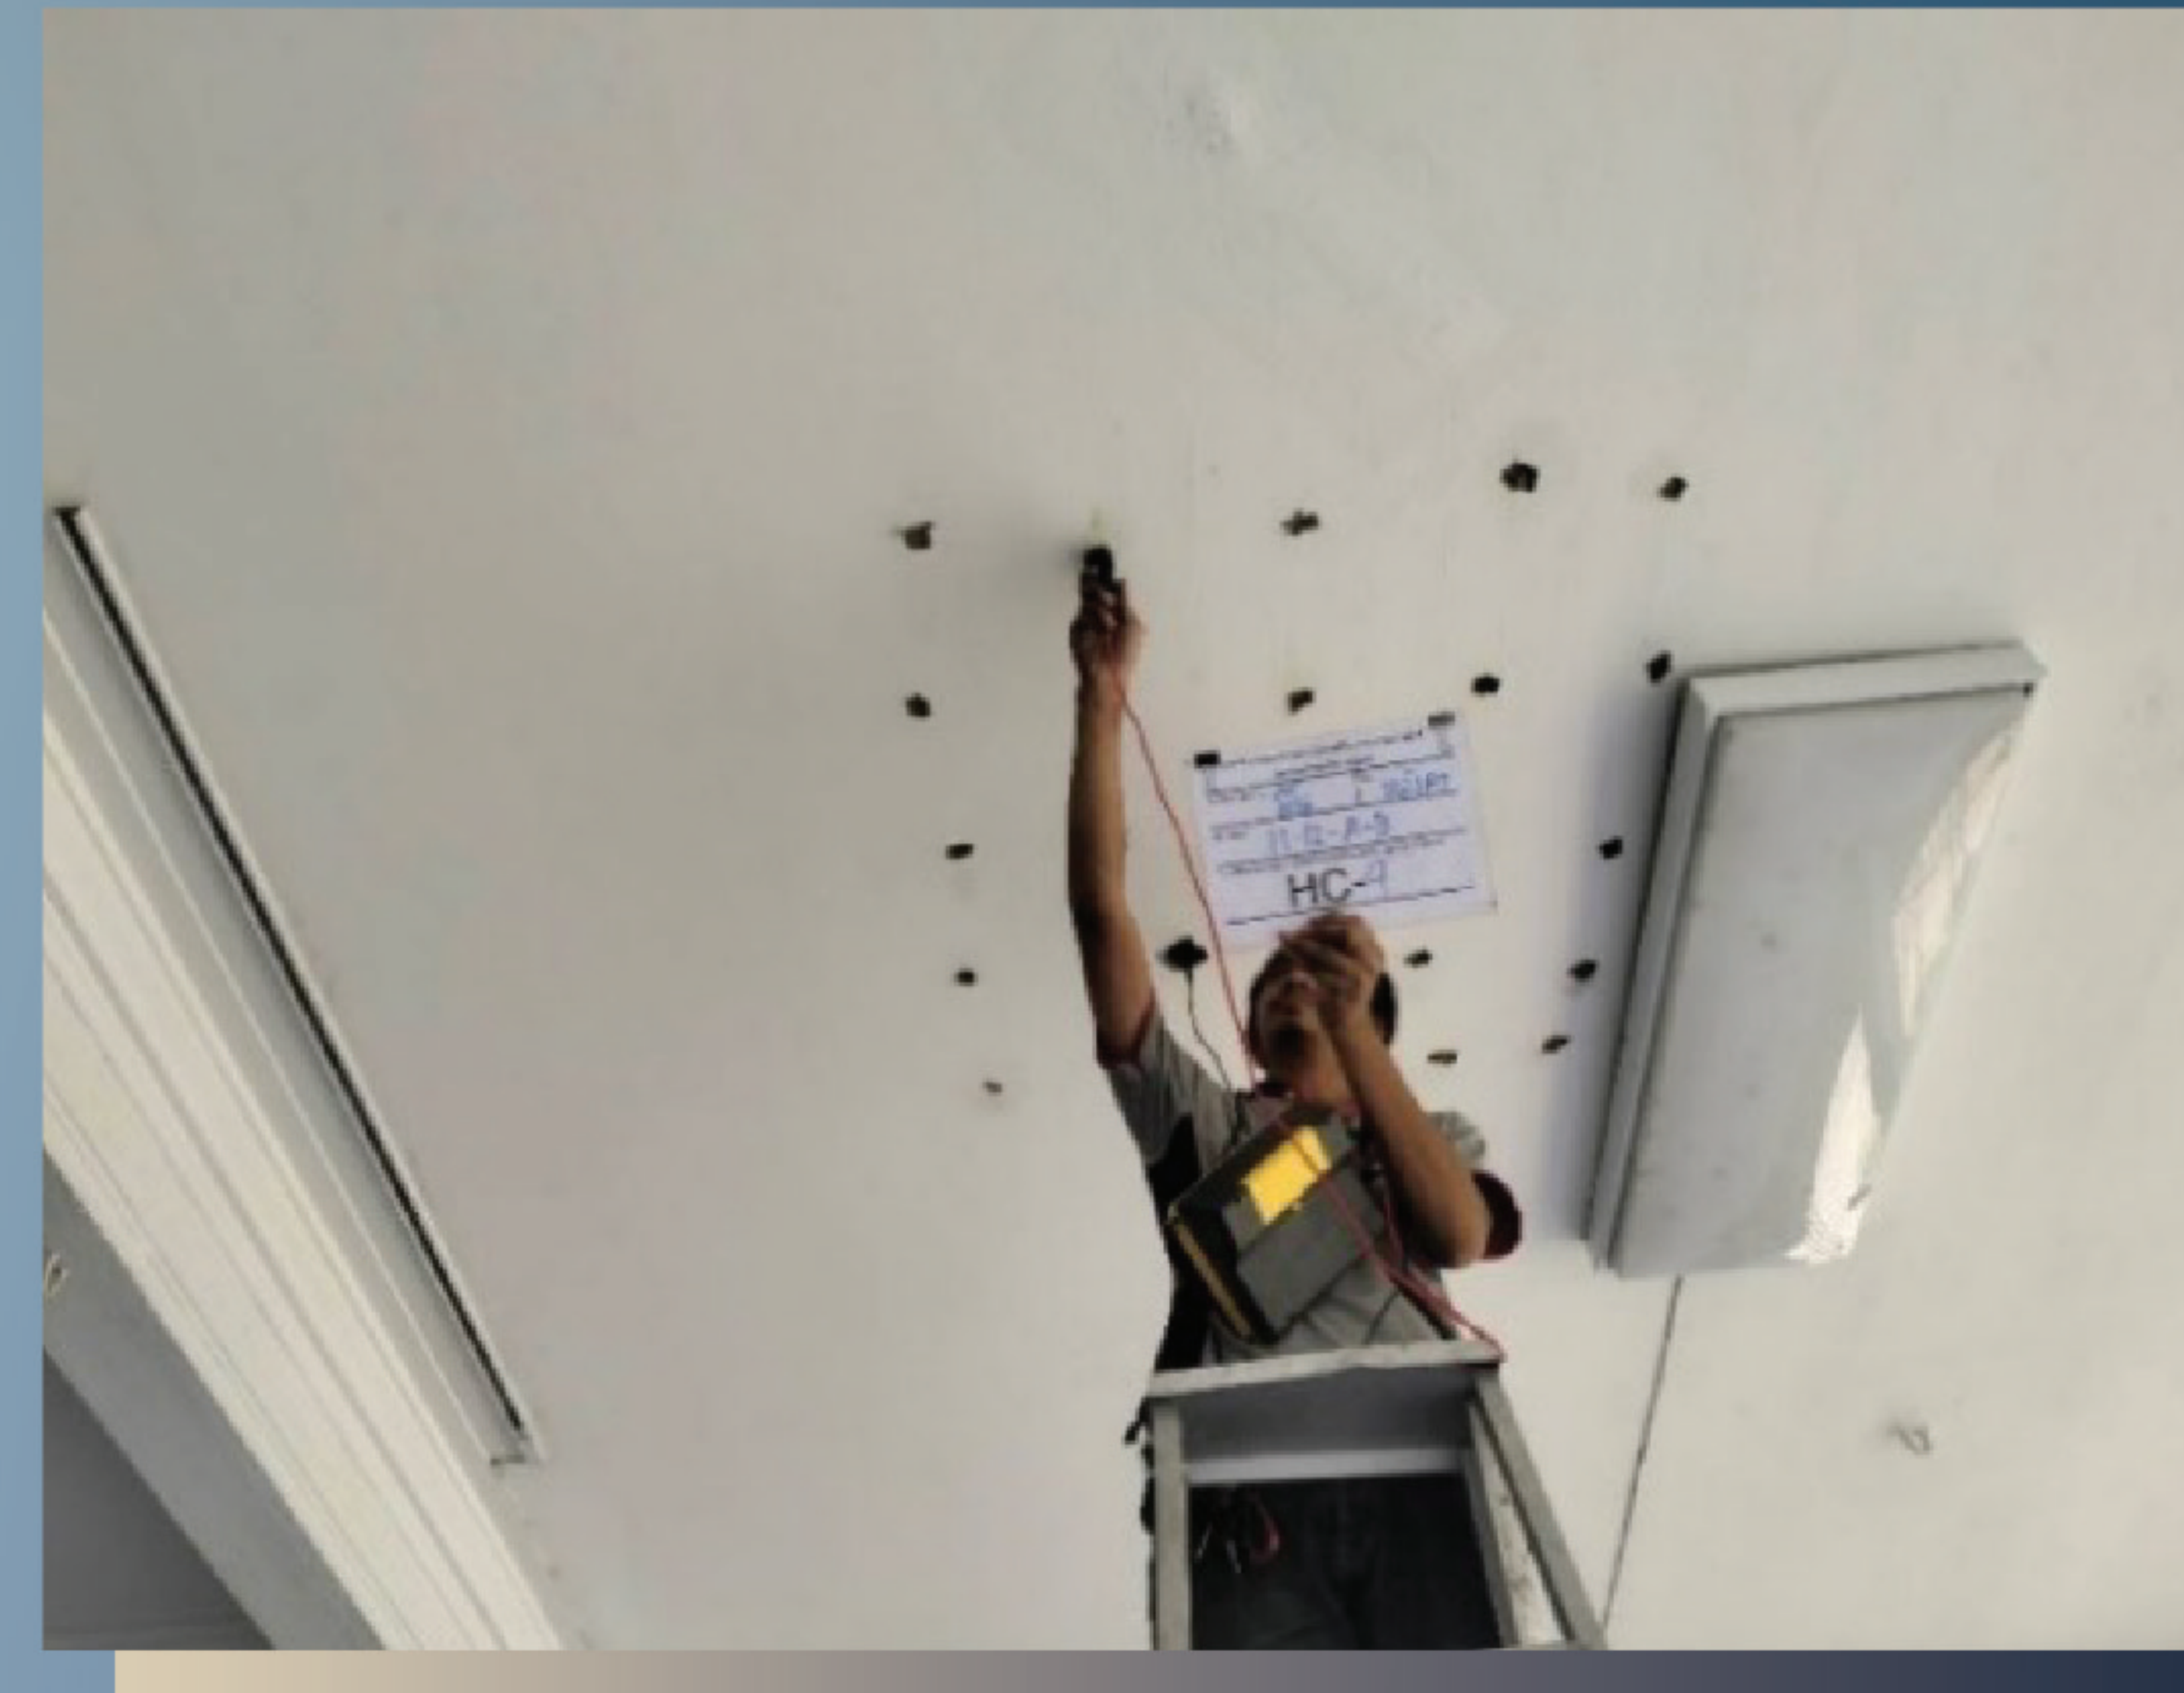
Floor Load Test and Half-Cell Potential Test

1.4 Floor Load Test showed that

1.4.1 Dancing area can sustain a load at 290 kg./sq.m. (equivalent to a live load of 150 kg./sq.m.)

1.4.2 Second-floor verandah can sustain a load at 310 kg./sq.m. (equivalent to a live load of 150 kg./sq.m.)

2. Reinforcement corrosion by Half-Cell Potential Method (10 locations)

- 90% probability of no reinforcement corrosion at 5 locations tested.
- Chance of having or not having reinforcement corrosion at 4 locations tested.
- 90% probability of having reinforcement corrosion at 1 location tested.
