Executive Summary

Structural Investigation and Stability Analysis

THE ROYAL BANGKOK SPORT CLUB

(From year 2010-2020)

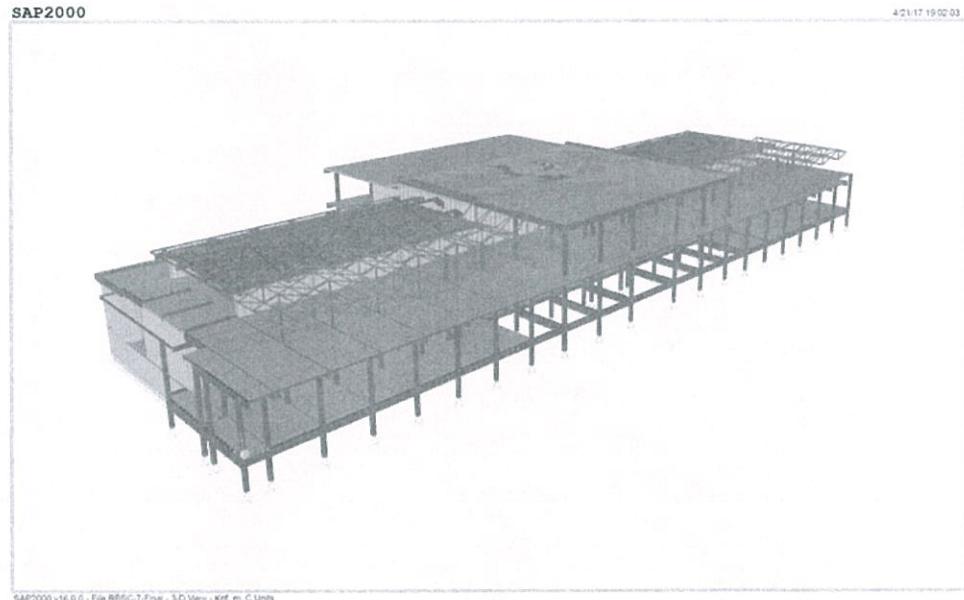
Figure 04 3-Dimensional mathematical model

In year 2017, the detail structure stability analysis has been done to evaluate the actual safe service load. The complete 3-dimensional model of the building, shown in Figure 04, was set up. The analysis was carried out by finite element method using structure program “SAP2000”. Base on the structural analysis results, the safe service live load for ground floor and upper floor slab are advised in Figures 05 and 06, respectively.
